FRUITLAND OUTCROP MONITORING REPORT

LA PLATA COUNTY, COLORADO

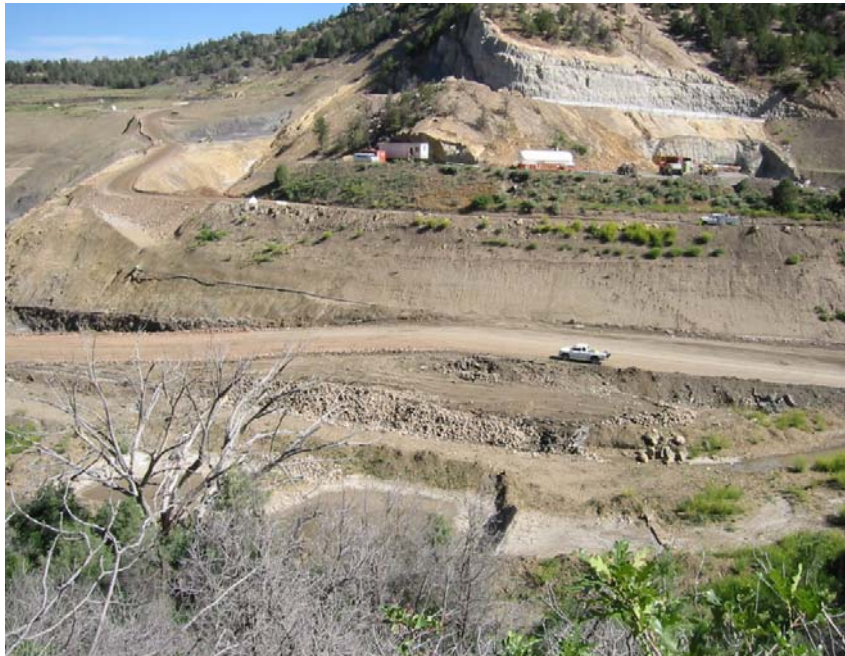
Construction activities at Basin Creek, view north.

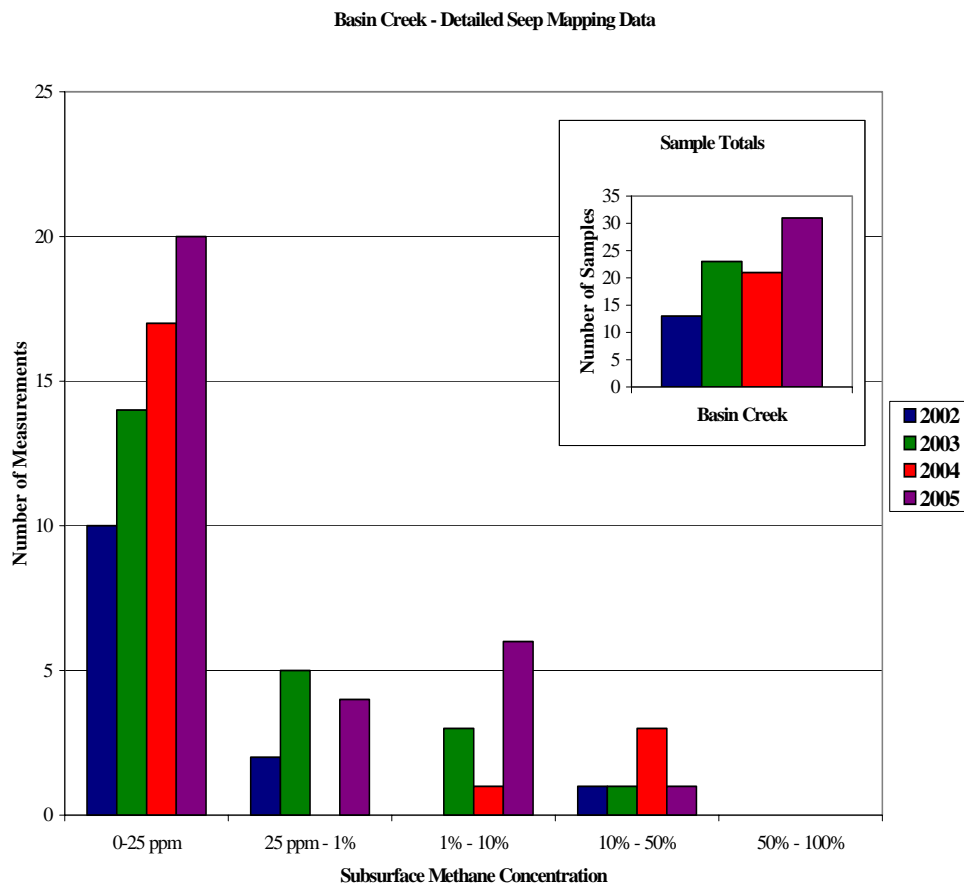
The number of subsurface methane measurement locations at Basin Creek has increased since detailed mapping commenced in 2002. When comparing concentrations collected from previous years to those collected in 2005, the highest concentrations detected are relatively similar and occur in the same areas in Basin Creek. The most recent data do not indicate the presence of new seep areas in the Basin Creek mapping area. The following chart illustrates the number of samples collected during each detailed mapping event and the distribution of the concentration values. Figure 3 illustrates the historical subsurface methane concentration data for Basin Creek.

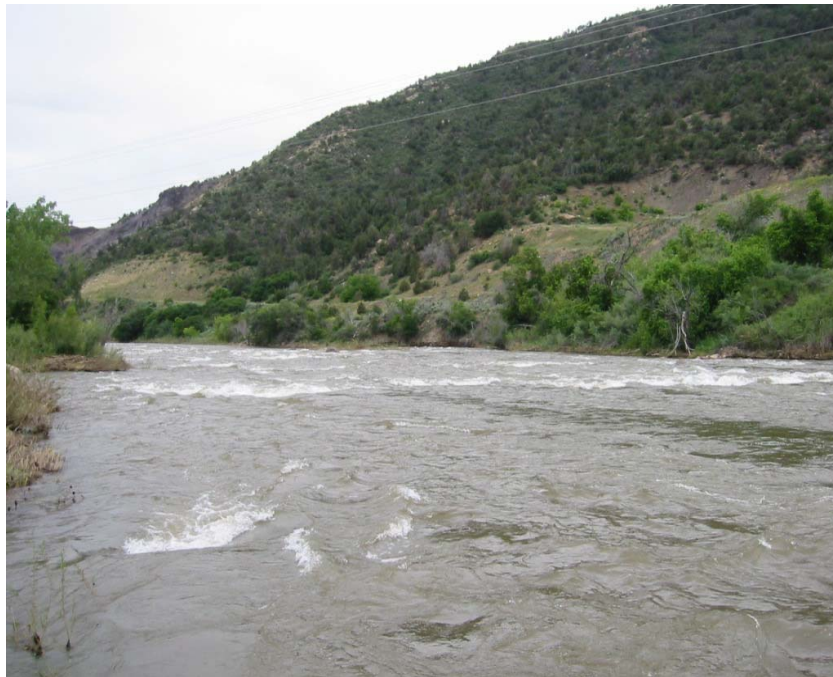
Animas River at Carbon Junction, view south.

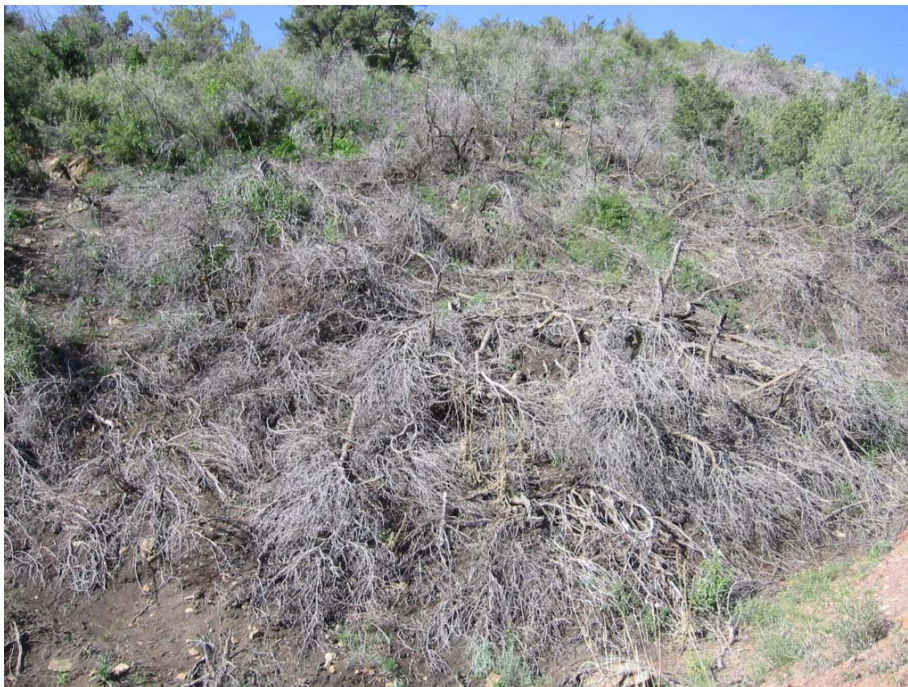
Dead scrub oak west of shooting range, text reference CJ-3, view west.

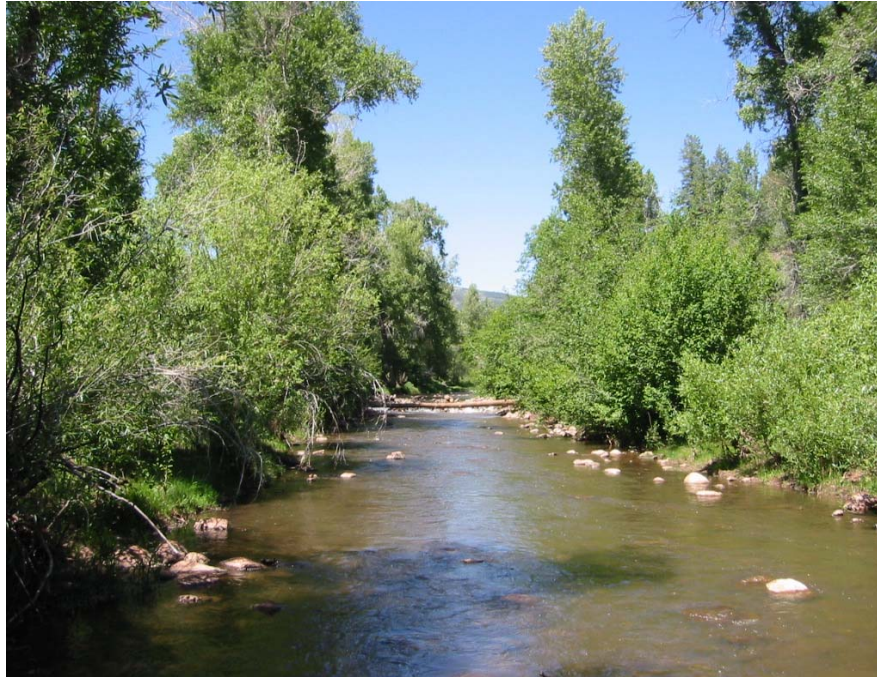
Florida River,
view north.

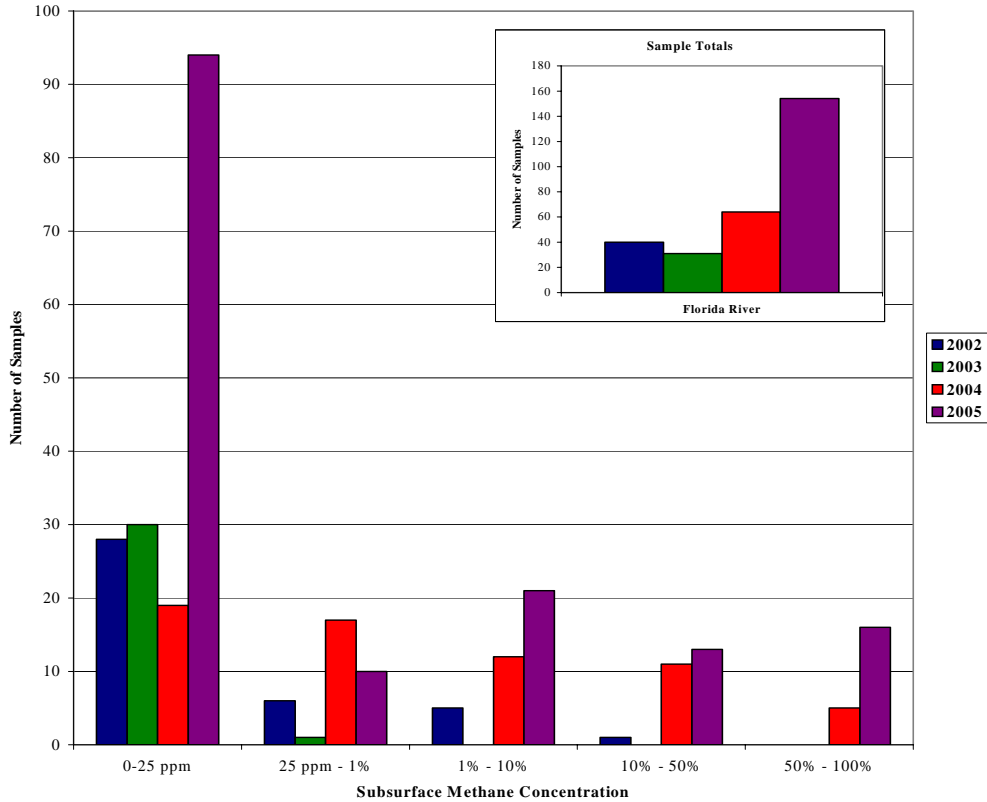
4.4 SOUTH FORK TEXAS CREEK

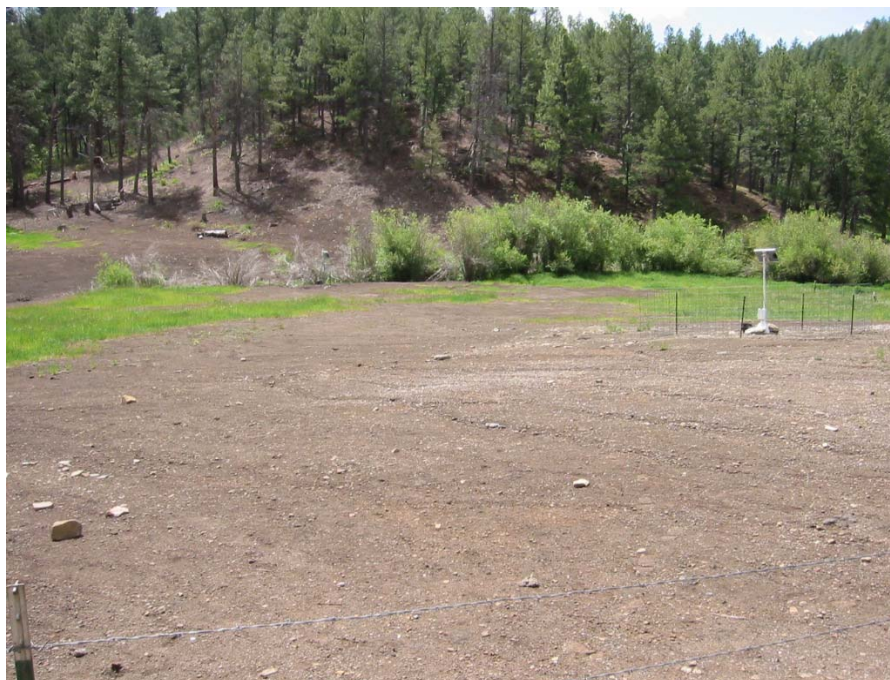
Non vegetation area, text reference TC-1, view south.

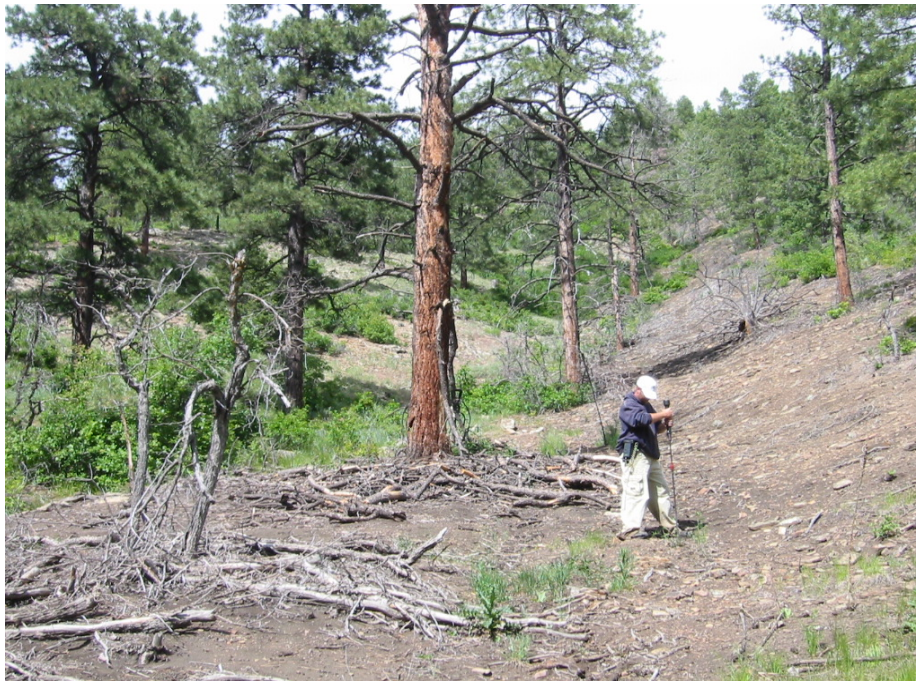
Text reference
TC-5, view
northeast.

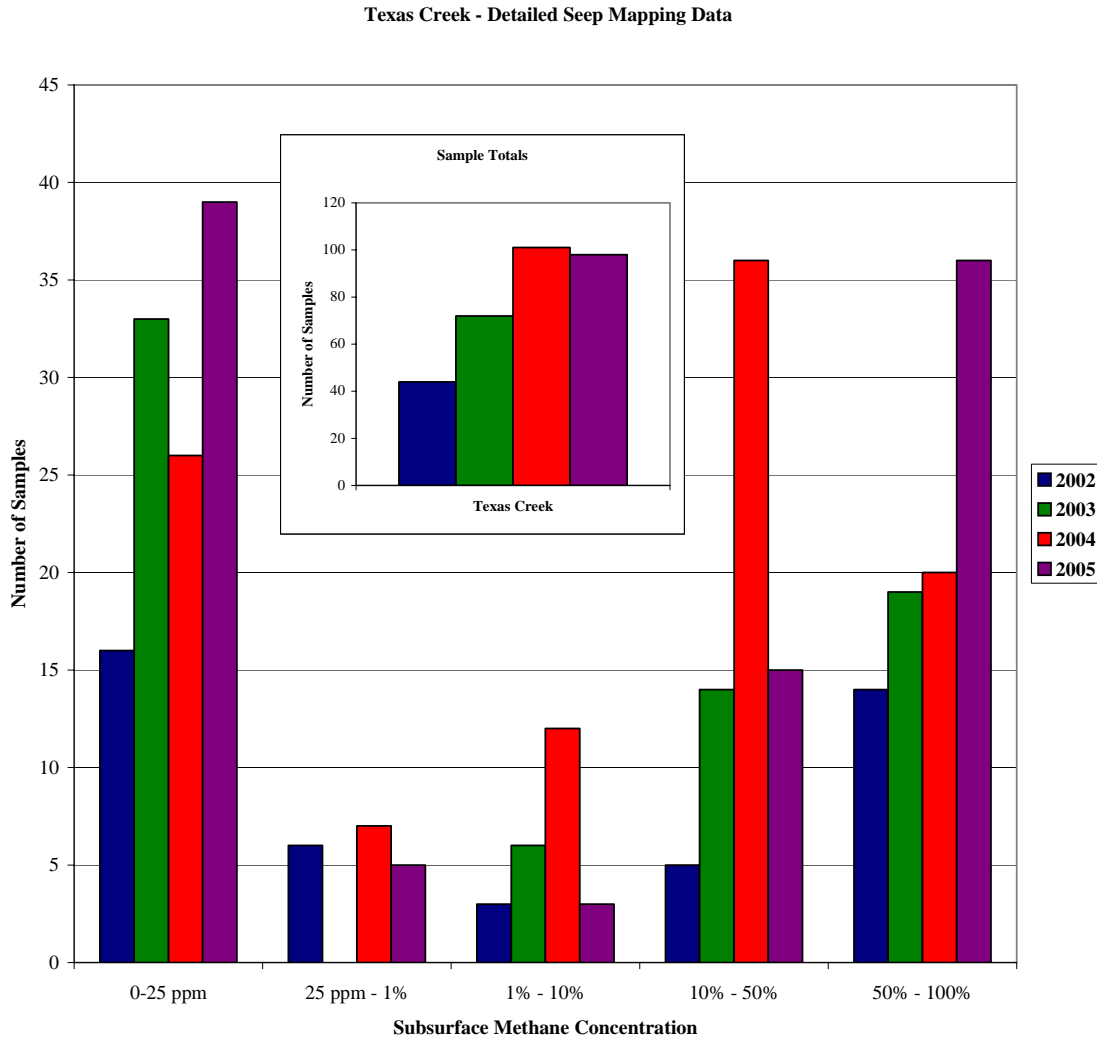
The number of subsurface methane measurements collected at Texas Creek East in 2005 is relatively consistent with the number collected during previous mapping events. In general, the methane concentration measurements collected at Texas Creek East during 2005 appear to be consistent with concentration measurements collected from previous mapping events. A chart illustrating the distribution of historical mapping data at Texas Creek East is presented below. Figures 19 and 20 illustrate the distribution of historical subsurface methane measurements at Texas Creek and Texas Creek East.

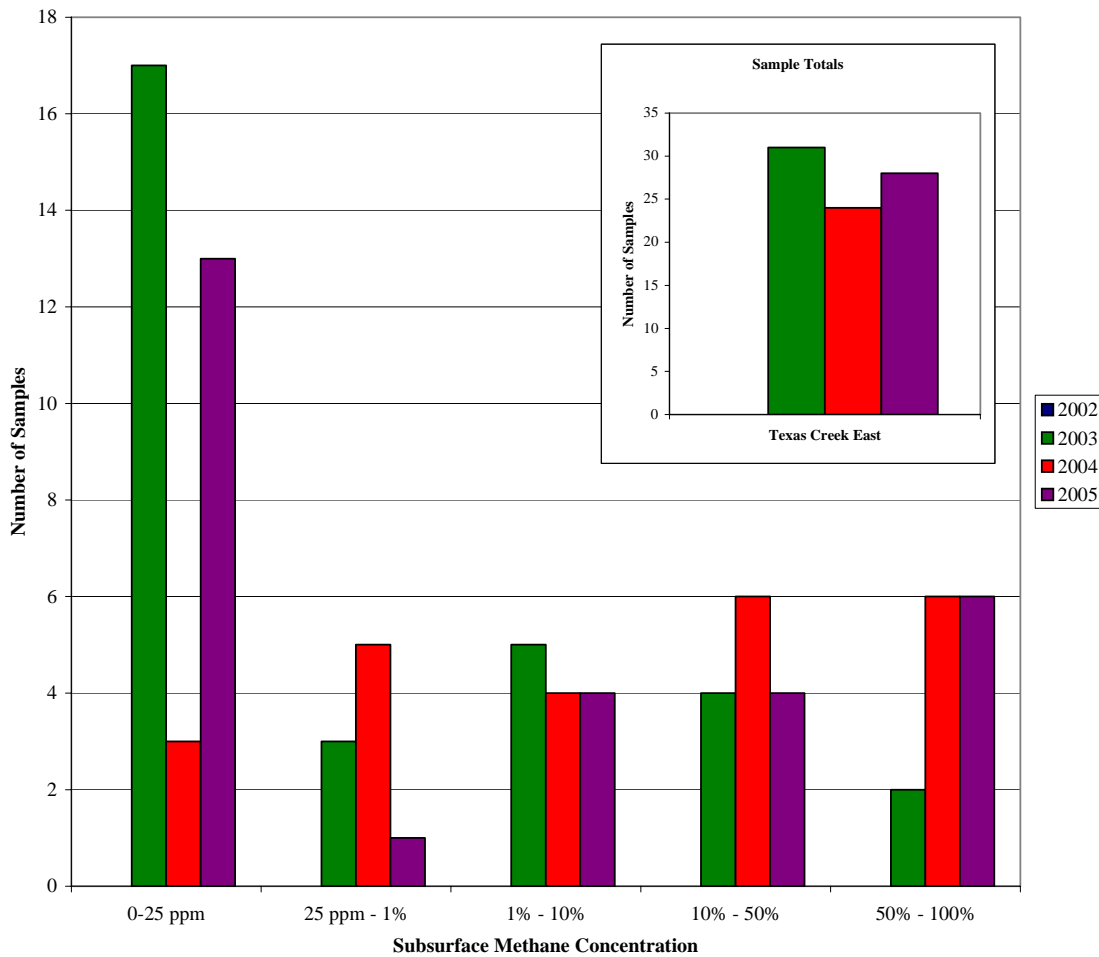
The visible seeps mapped in 2003, 2004, and 2005 remain relatively consistent. The number of visible seeps mapped in 2002 was low because the creek was relatively dry. However, several seeps were noted to the northeast of the main seep area during the 2002 mapping event (blue circles on Figure 23). This area around the visible seeps was not mapped during the 2003, 2004, or 2005 mapping events due to restricted access. Figure 23 illustrates the historical data comparison of visible methane seeps.

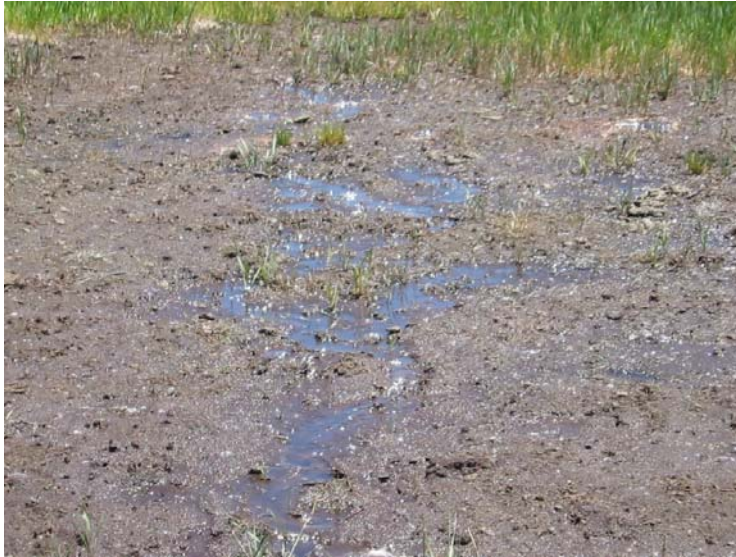
Methane seeps in field located east of Pine River, text reference PR-2, view east.

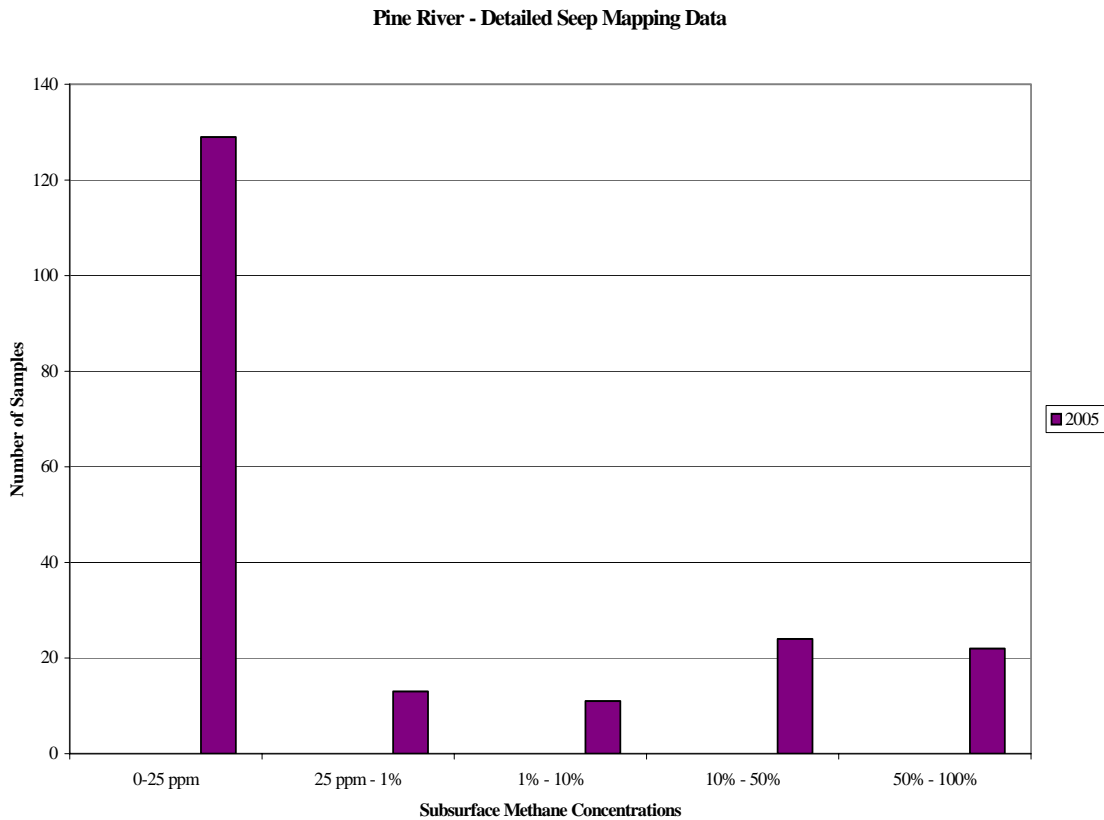
4.7 DETAILED MAPPING SUMMARY

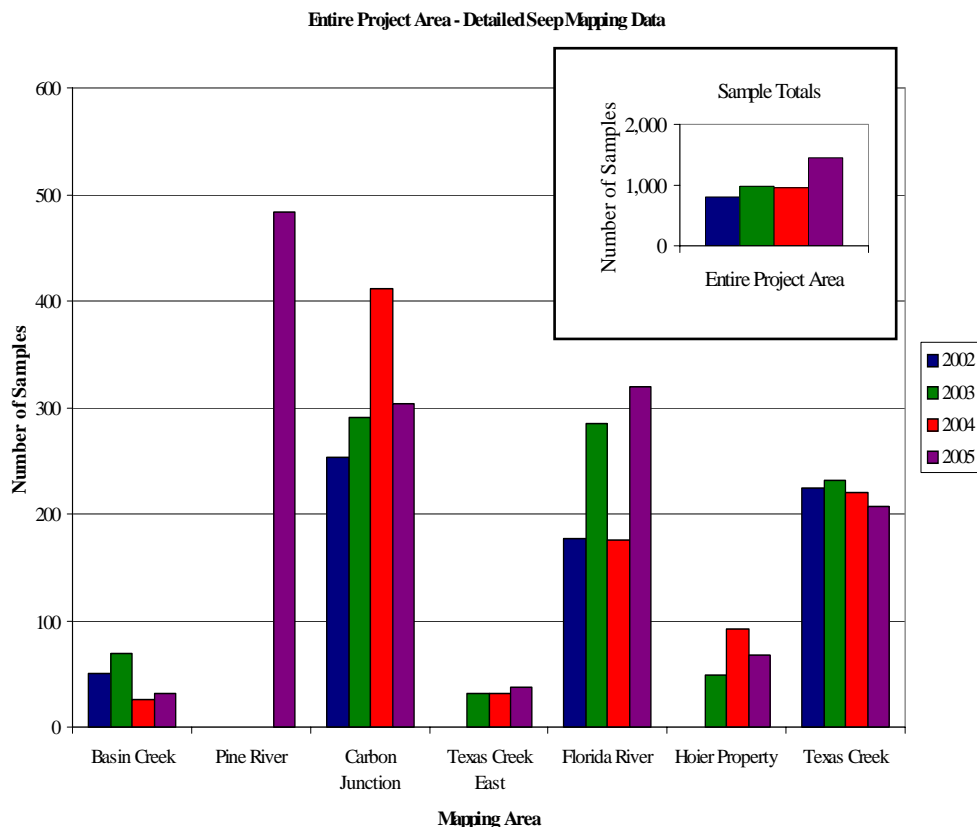
The number of features mapped during 2005 at Carbon Junction was less than the number mapped during 2004, but consistent with the number mapped during 2002 and 2003. At Florida River, the number of features mapped during 2005 increased from 2004, but was consistent with 2003. A chart summarizing the number of sampling points collected across the study area since 2002 is presented below.

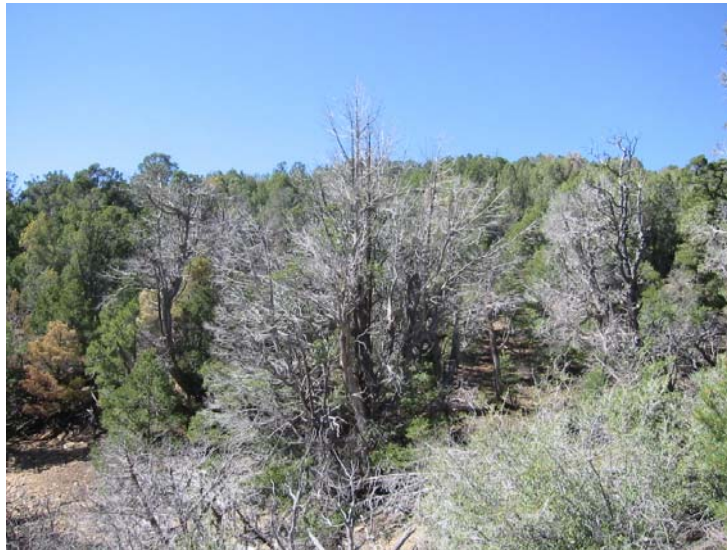
Dead pine trees,
text reference
M05-2, view
northwest.

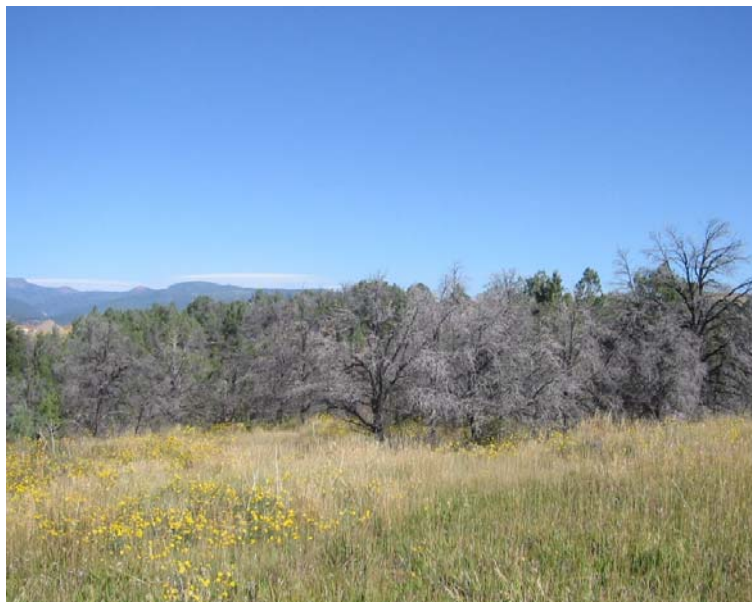
Text
reference
M05-6,
view west

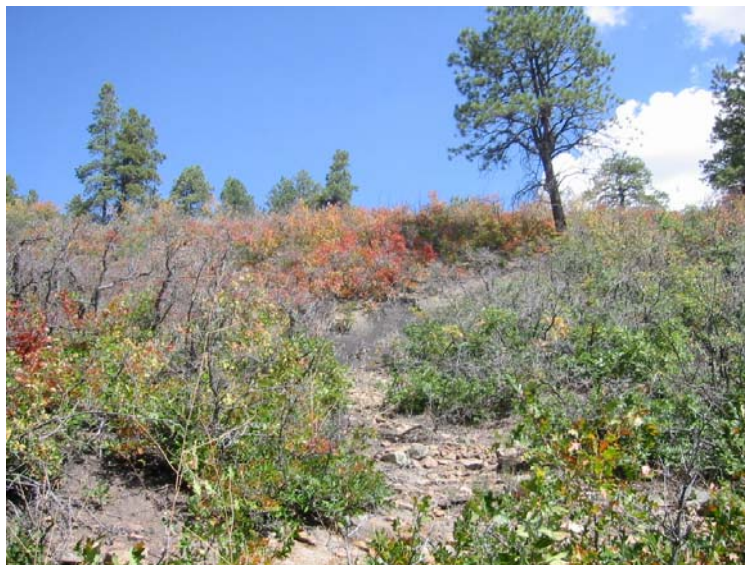
Coal seam and stressed scrub oak, text reference M05-17, view east.

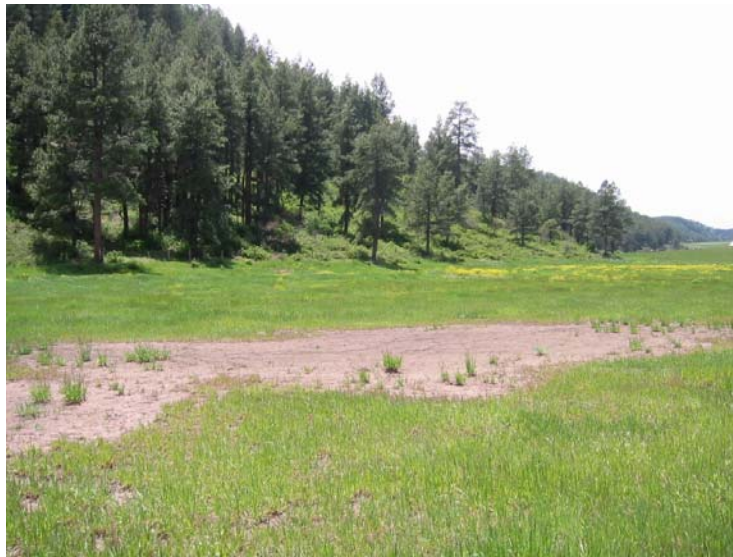
Suspect area with elevated methane concentrations, text reference M05-21, view southwest.

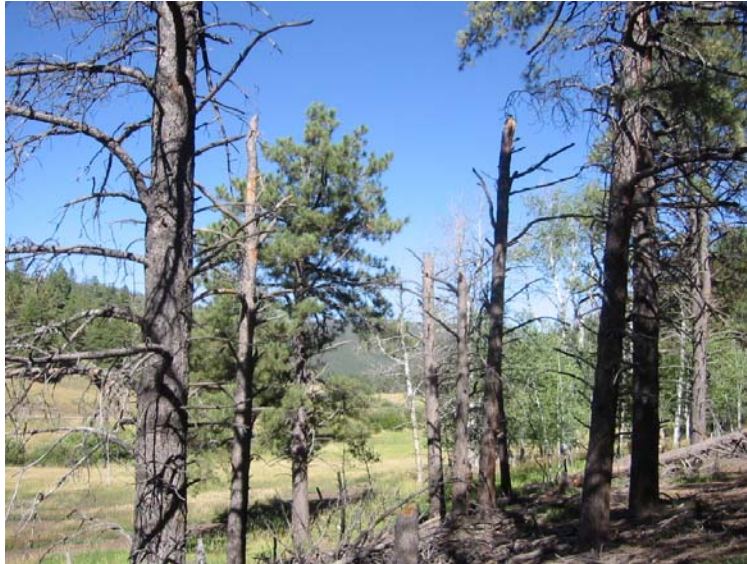
Tree mortality in area of elevated methane concentrations, text reference M05-23, view east.

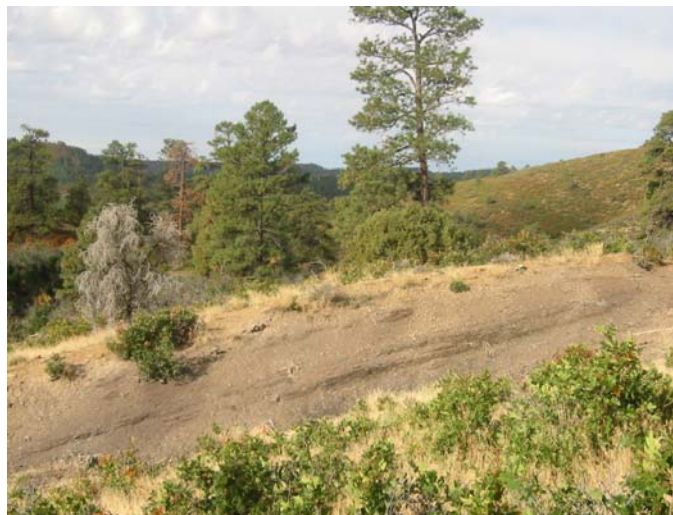
Dead pine tree and coal at base of outcrop, text reference M05-30, view west.

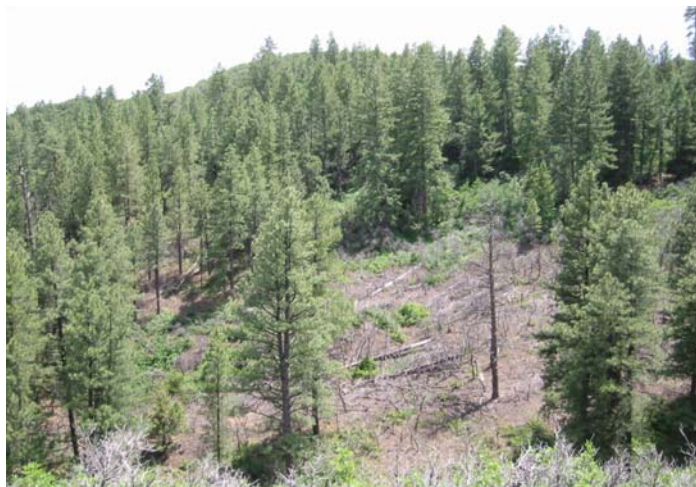
Vegetation mortality in area of elevated methane concentrations, text reference M05-31, view south.

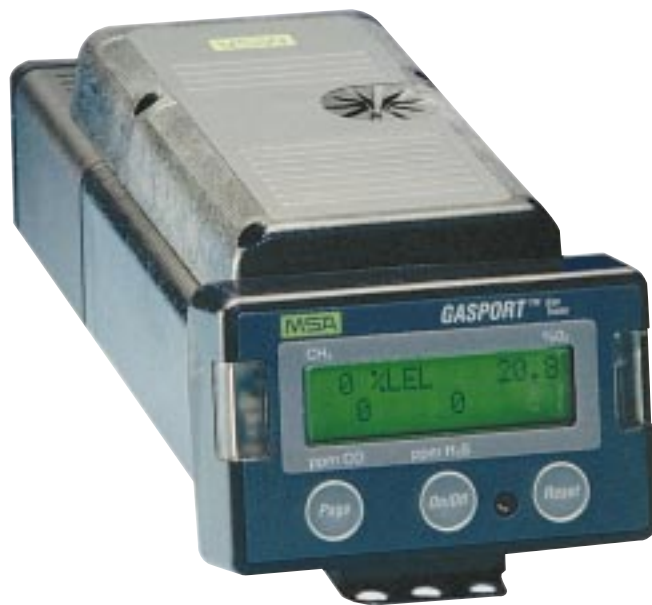
Features and Benefits
