FRUITLAND OUTCROP MONITORING REPORT

LA PLATA COUNTY, COLORADO

JANUARY 2007

LT ENVIRONMENTAL, INC.
4600 West 60th Avenue
Arvada, Colorado 80003
(303) 433-9788

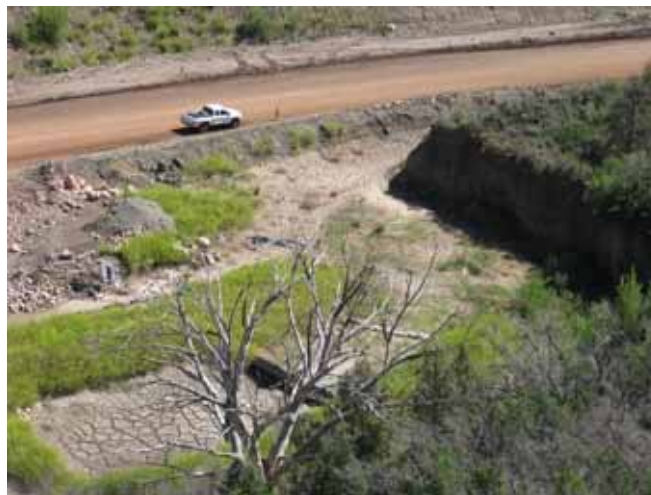
The streambed in the Basin Creek area was not mapped due to ALP dam construction activities. The construction of the dam and removal of vegetation caused large quantities of sediment to accumulate in the stream bed, thus making the area inaccessible for seep mapping since 2004. The areas adjacent to the stream bed were mapped as planned, but based on recent observations, the construction area appears to be steadily increasing in size, reducing the observable seep features and further limiting access to map and monitor seep activity at Basin Creek. A photograph of the Basin Creek mapping area is shown below.

Construction activities at Basin Creek, view northeast.

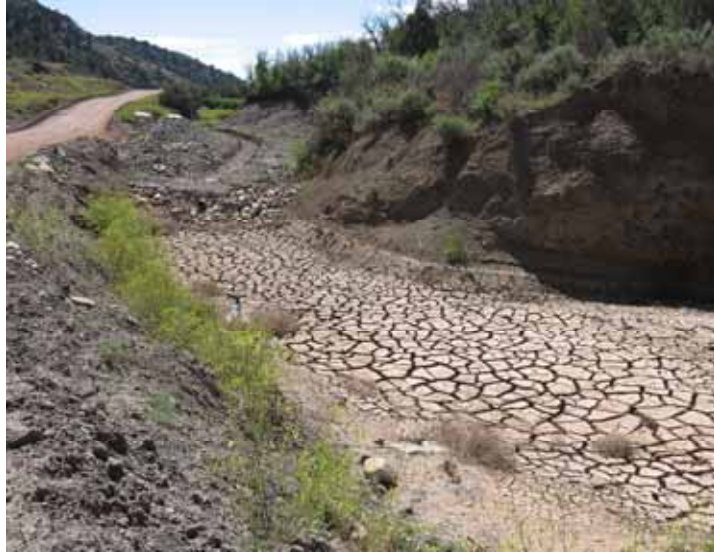
No surface water was observed in the Basin Creek mapping area during the 2006 detailed mapping event. The absence of water in the stream bed is most likely the result of drought and/or sedimentation associated with construction activities.

Sedimentation
in Basin Creek,
view east.

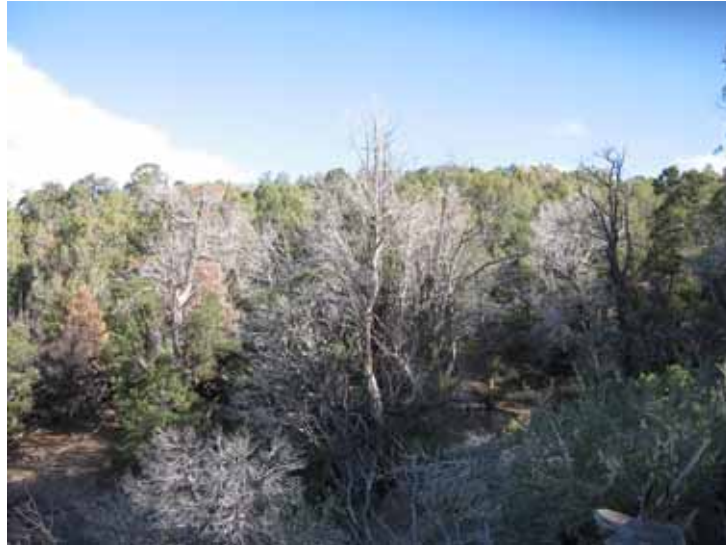
The upland area located approximately 0.25 miles north of Basin Creek was added to the detailed mapping program during the 2006 field activities after methane was detected in this area during the 2005 regional reconnaissance activities (BC-2, Figure 3). LTE collected 17 subsurface measurements in this area and nine of the measurements indicated detectable concentrations of methane. The detectable methane concentrations in this area ranged from 1,000 ppm (0.1%) to 29%. A total of four measurements reported methane concentrations that were greater than 5%. Several stressed/dead pines and junipers were noted in this area. Rocky soil and evidence of beetle infestation were also observed in this upland area.

Stressed/dead
vegetation area
north of Basin
Creek, view
northwest.

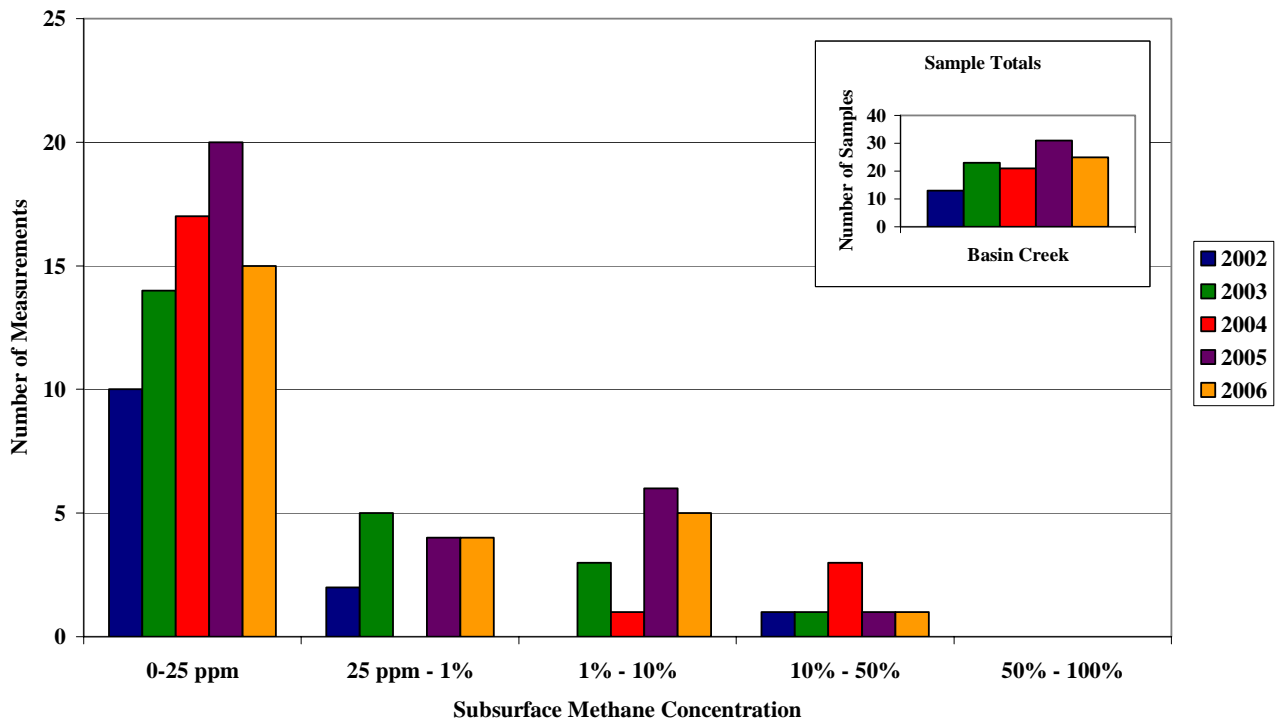
Basin Creek - Detailed Seep Mapping Data

As a result of drought and/or continued sedimentation, no surface water was observed in Basin Creek in 2006. Therefore, it was not possible to map visible methane seeps in the streambed. Figure 6 illustrates the historical distribution of visible methane seeps in surface waters at Basin Creek. As described earlier, the base photograph was taken in 1993, prior to the ALP dam construction activity.

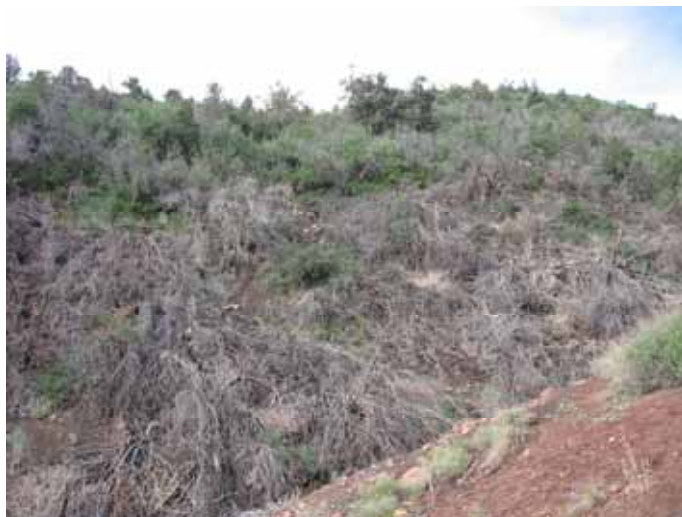
West of the shooting range, two stressed/dead vegetation areas and three stressed/dead trees were mapped (CJ-4, Figure 7). Dead scrub oak had been noted during previous detailed mapping events in this area. Detectable methane concentrations ranged between 3,000 ppm (0.3%) and 84% in this area. The average detectable methane concentration reported in this area was 27%. Three of the 12 measurements reporting detectable concentrations of methane were greater than 50%. H₂S was detected at two locations in this area at concentrations of 4 ppm and 50 ppm (Figure 7).

Stressed/dead scrub oak west of shooting range, text reference CJ-4, view west.

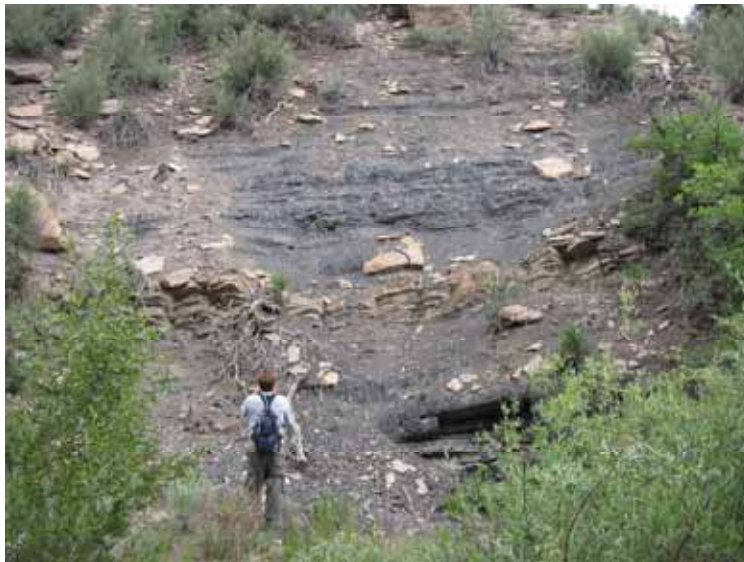
Several large areas of stressed/dead vegetation, many stressed/dead trees, and relatively high concentrations of methane were noted in an upland area along the base of the Kf in a drainage near the Kpc – Kf contact (CJ-7, Figure 8). A relatively large coal outcrop was observed near the bottom of the drainage.

Coal outcrop in drainage near Kpc-Kf contact, view southeast.

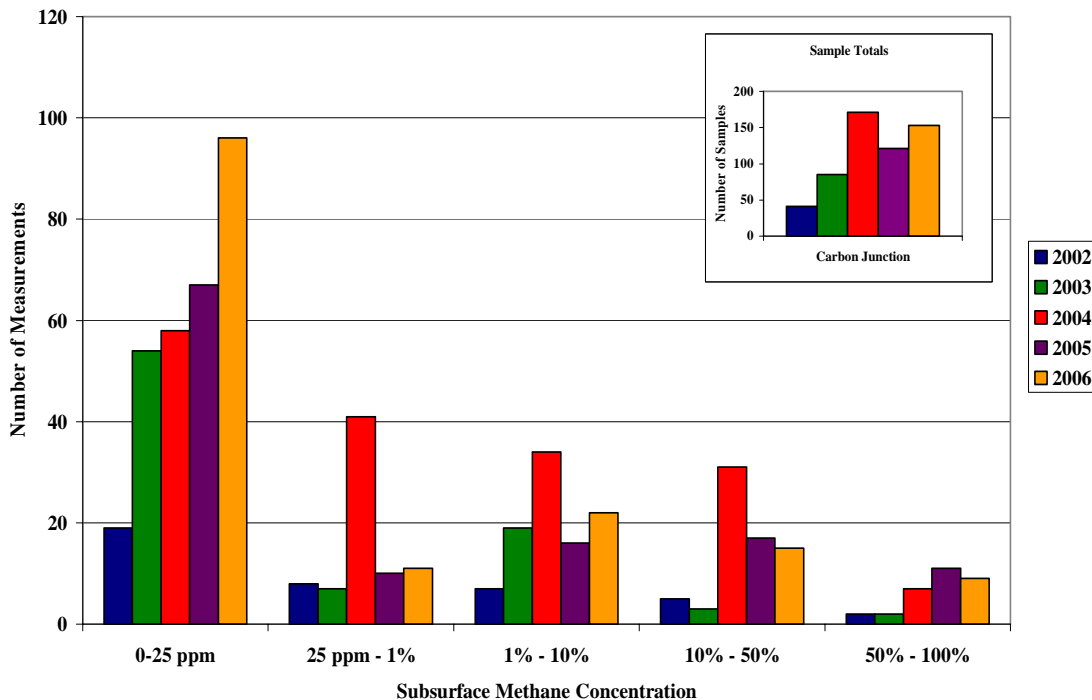
Carbon Junction - Detailed Seep Mapping Data

H₂S was detected at three locations east of the Animas River and two locations west of the Animas River. Three of the sample locations reported H₂S concentrations of 50 ppm. These are the highest hydrogen sulfide concentrations that have been reported in La Plata County since LTE began the detailed seep mapping program. The maximum concentration of H₂S recorded during 2005 was 10 ppm.

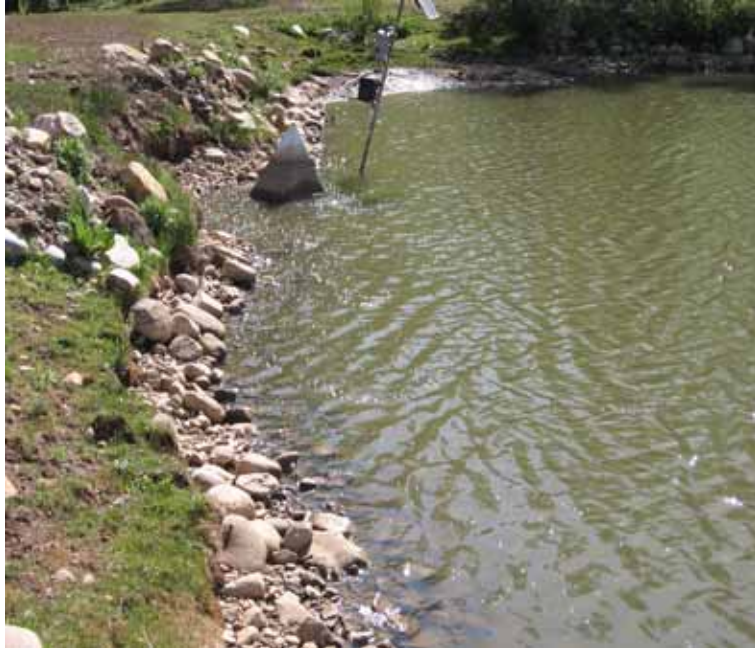
Numerous visible methane seeps were noted in the private pond located at Terry Palmer Ranch. In general, the methane seeps appear to form trends in the east to west direction, roughly paralleling the strike of the Kf. Methane seeps were also identified in the Florida River east and north of the private pond. Methane seeps were noted for approximately 0.07 mile upstream (north) of the private pond.

Visible methane seeps in private pond, view east.

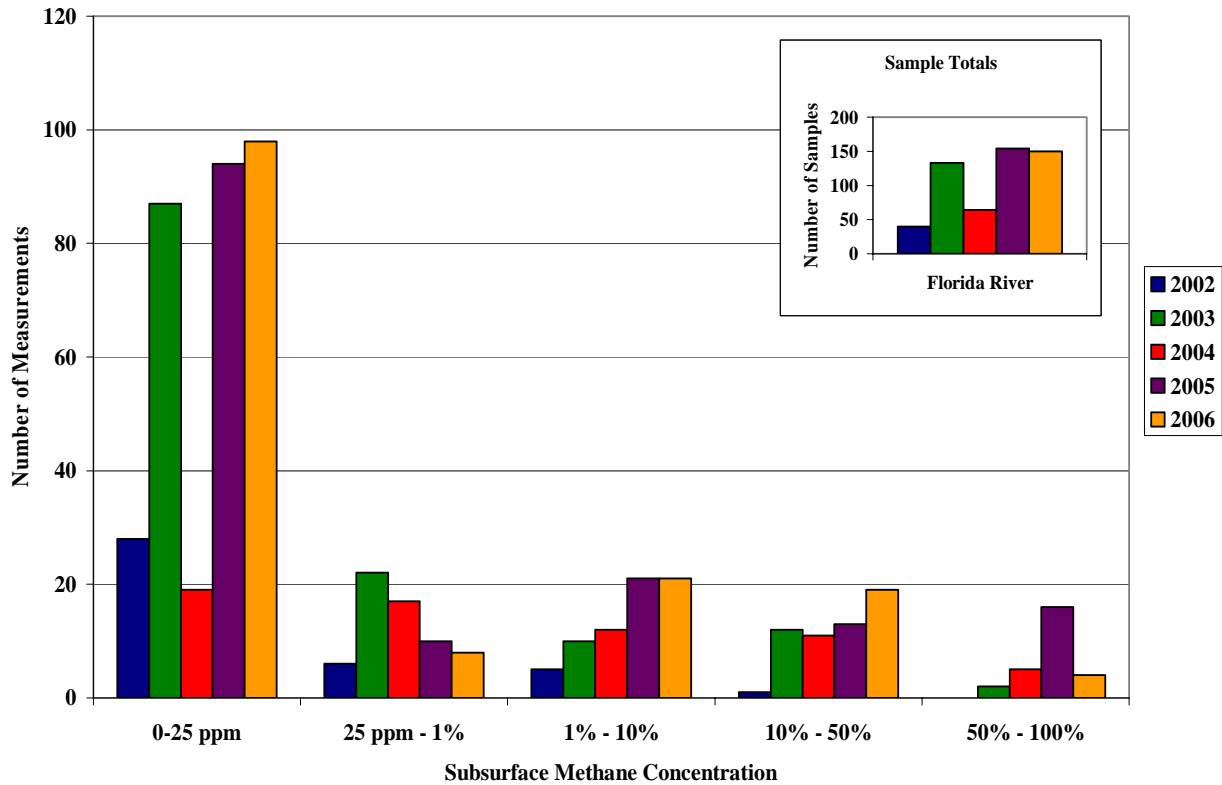
Florida River - Detailed Seep Mapping Data

In general, the number of stressed/dead vegetation areas mapped in 2006 appears to be relatively consistent with the number of vegetation features mapped between 2003 and 2005. More stressed/dead vegetation areas were mapped southwest of the private pond on the Terry Palmer Ranch in 2006 than in previous years. However, fewer stressed/dead vegetation features were mapped east of the pond in 2006 than in previous years. When comparing the areal extent of stressed/dead vegetation features mapped at Florida River from year to year, a slight decrease is noted in the meadow west of CR 234 and in the upland area north of CR 237. However, a slight increase in the areal extent of stressed/dead vegetation features is noted in the area north of the pond near the Turner residence. Figure 15 illustrates the historical data comparison of stressed/dead vegetation at the Florida River mapping area.

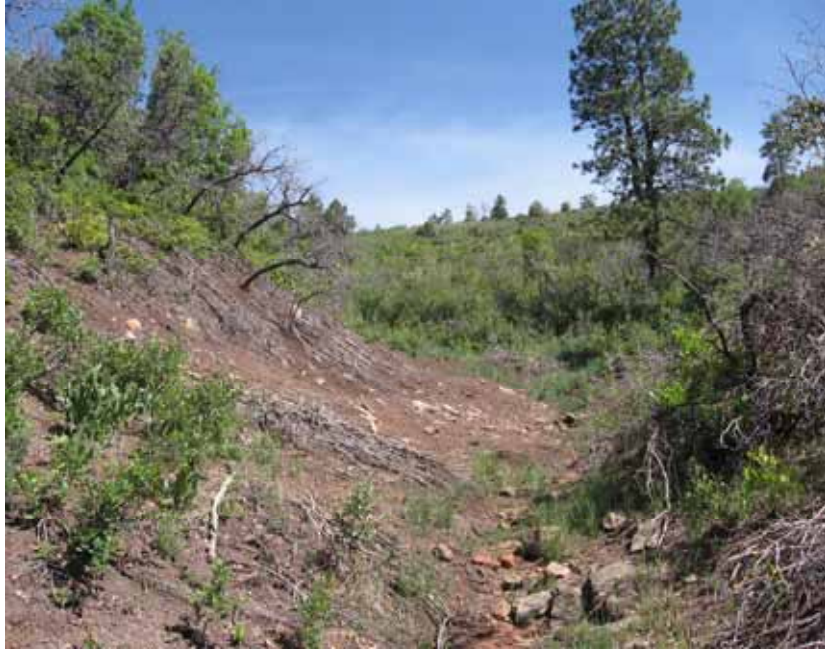
LTE observed a stressed/dead vegetation area located approximately 0.25 miles east of VP-1 (VP-2, Figure 17). This area is a topographically low area within an upland area of the Kf outcrop. Methane and H₂S were detected in this area at a concentration of 5%, and four ppm, respectively. Four subsurface gas measurements were collected around the perimeter of the stressed/dead vegetation area. Methane and H₂S were not detected in any of the sample points located around the perimeter of the stressed/dead vegetation area.

Stressed/dead
vegetation area,
text reference
VP-2, view
south.

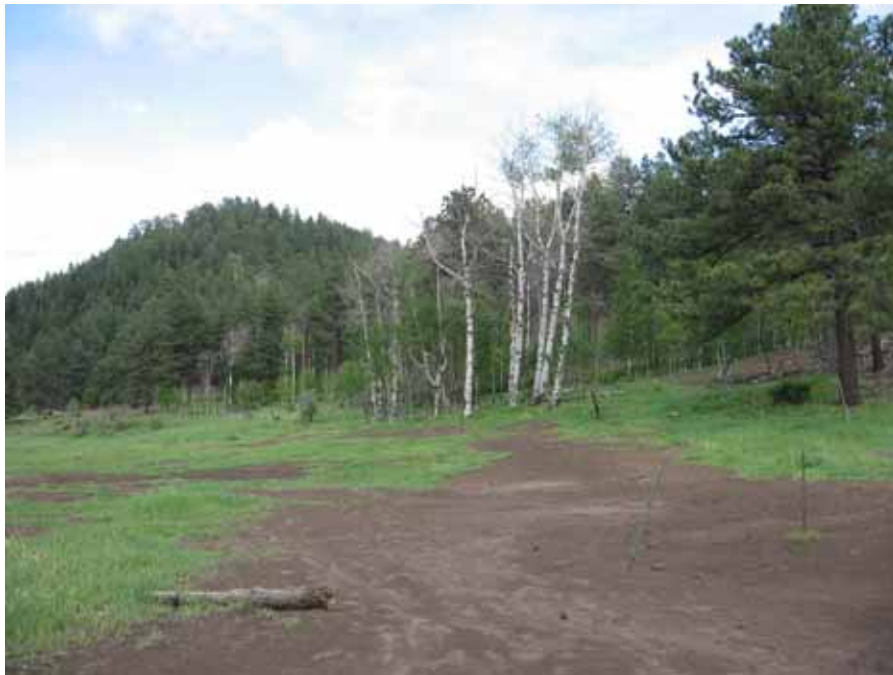
Stressed/dead and non-vegetation patches were mapped throughout the valley floor of the SFTC study area. The largest stressed/dead and non-vegetation areas were noted in the center of the mapping area where the creek transects the Fruitland Formation and Pictured Cliffs Formation contact (TC-3, Figure 20). A grid mapping system was used in this area as previously discussed in Section 2.2.4. LTE advanced a total of 82 subsurface probes across this area, covering approximately 10 acres. Results of the survey indicate that elevated methane was detected in the main seep area covering approximately 3.5 acres. Methane was detected in 28 of the 82 subsurface probes. Detectable concentrations of methane in this area ranged from 140 ppm (0.014%) to 100%. The average concentration of detectable methane was 57% and 13 of the 28 detectable methane concentrations were greater than 50%. Methane concentrations of 100% were recorded in four of the subsurface probes. H₂S was reported at three locations in the vicinity of the gas flux chamber at concentrations of ranging from 1.0 to 2.0 ppm

Non-vegetated area east of gas flux chamber, text reference TC-3, view east.

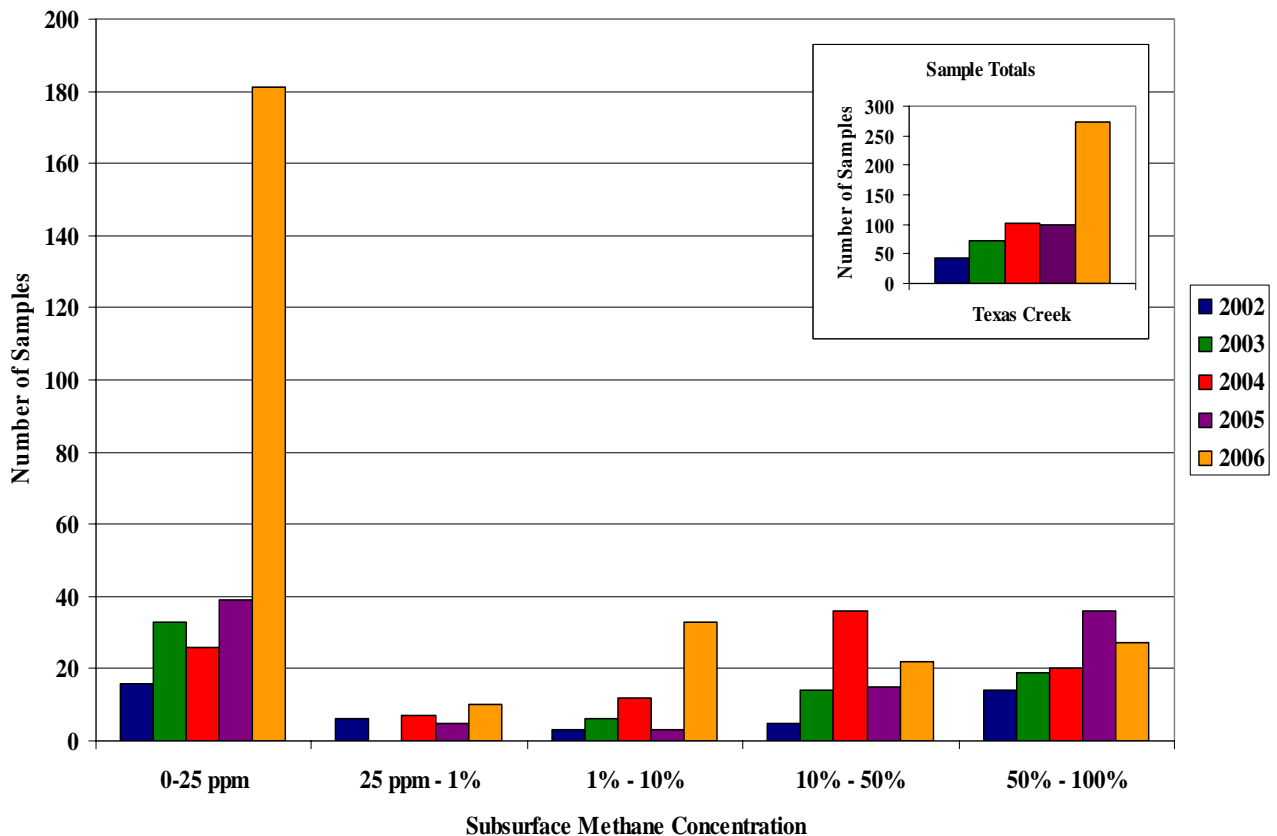
Texas Creek - Detailed Seep Mapping Data

When comparing the areal extent of stressed/dead and non-vegetation areas at SFTC over time, it appears that decreases in the areal extent of vegetation features are noted more often than increases. These decreases are most evident in the western portion of the SFTC valley and within the main seep area. Additionally, several areas mapped within the main seep area during previous years were not mapped during 2006. However, a greater number of vegetation areas were mapped on the Ward property in 2006 than in previous years. LTE was only granted access to map the Ward Property in 2002 and 2006. In general, the areal extent of stressed/dead vegetation areas mapped on the Ward property in 2006 appears greater than the areal extent of the same areas mapped in 2002.

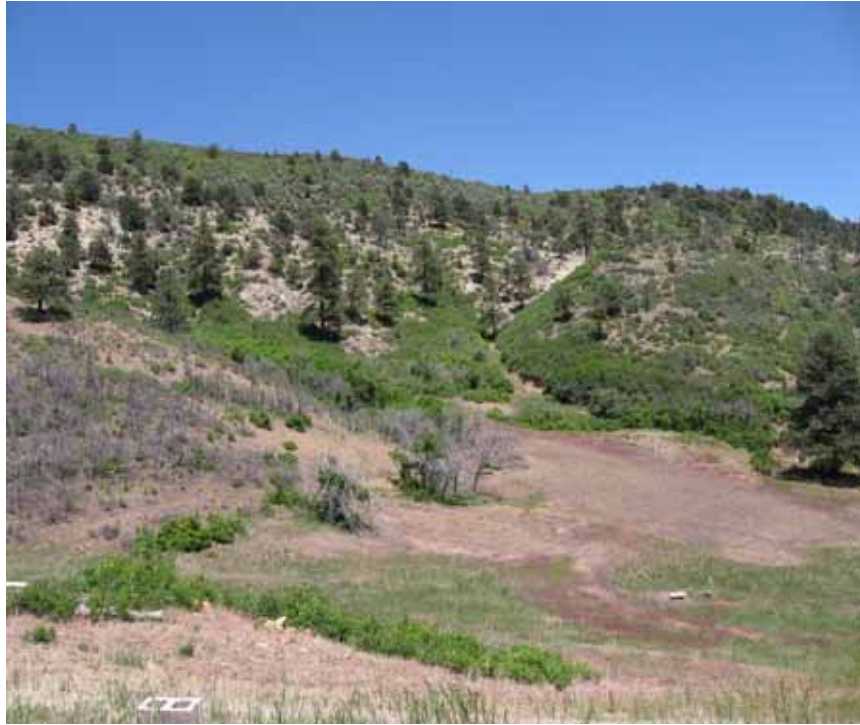
Stressed/dead
vegetation on
Hoier
property,
view east.

Several stressed/dead vegetation areas were mapped in the area north of the pond on the Hoier property (HR-1, Figure 32). A total of 50 gas measurements were collected at the Hoier property and 12 of the measurements reported detectable concentrations of methane. The detectable methane concentrations in this area ranged between 6,000 ppm (0.6%) and 76%. Nine of the 12 detectable methane concentrations were 5% or greater. Two areas of stressed/dead vegetation were mapped along the driveway east of the pond (HR-2, Figure 32). However, no methane was detected in these areas.

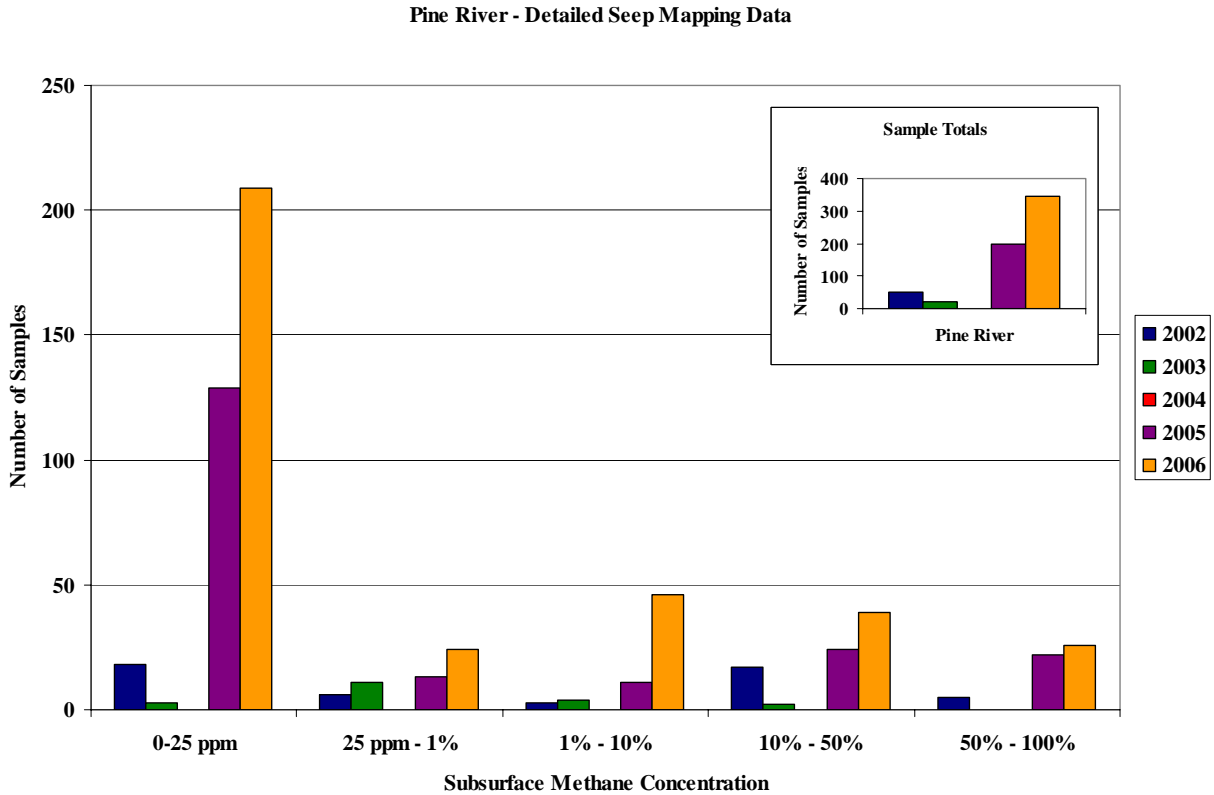
When compared to previous years, methane seepage was detected further northwest of the upland area west of Pine River. However, no historical data in this area is available for comparison. Therefore, it is possible that this condition existed prior to the 2006 detailed seep mapping event. Figure 37 illustrates the historical data comparison of methane concentrations. A chart illustrating the distribution of historical mapping data at Pine River is presented below.

When comparing the areal extent of stressed/dead vegetation features mapped in 2005 and 2006, decreases are noted more often than increases. In general, more individual trees were mapped east of the Pine River in 2005 than in 2006. The majority of this area was noted to be covered by standing water during the 2006 mapping event. Figure 38 illustrates the historical data comparison of vegetation features at Pine River.

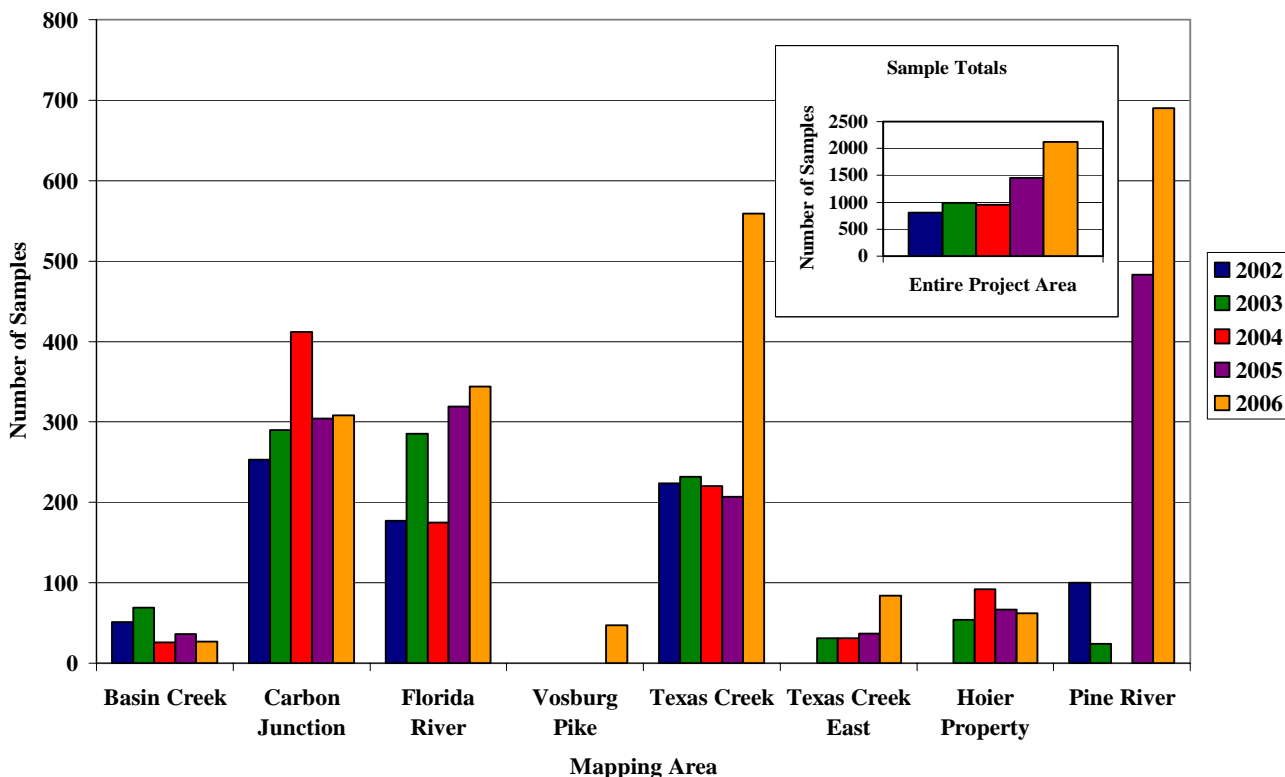
Entire Project Area - Detailed Seep Mapping Data

The total number of features mapped (including visible seeps, trees, vegetation areas, and subsurface methane measurements) over the entire project area in 2006 was higher than the previous mapping events. LTE collected 805 features in 2002, 985 in 2003, 956 in 2004, 1453 in 2005, and 2121 in 2006. This is primarily due to the use of a grid mapping system at the SFTC mapping area and the addition of Vosburg Pike and the area north of Basin Creek to the detailed seep mapping program. On a site by site basis, the largest difference in the number of features mapped was noted at Pine River. LTE mapped 483 features at Pine River in 2005 and 690 features in 2006. This increase is primarily due to the increased number of features mapped in the upland area between Pine River and the Hoier property, but may also be attributed to an increase in the methane seepage.

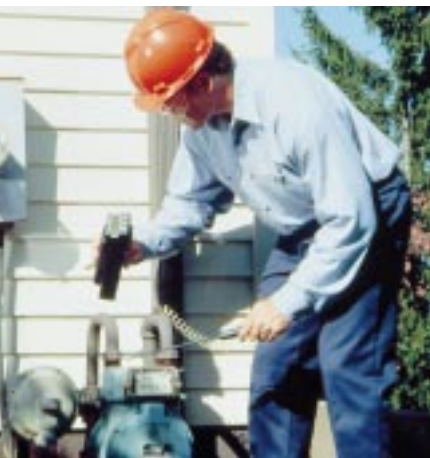
The Gasport Gas Tester is designed for gas utility workers to detect methane and certain toxic gases. It is a reliable, simple, versatile tool to help your service technicians get the job done quickly! With multiple ranges and sensing capabilities built into one rugged housing, the Gasport Tester simplifies your work by reducing the number of meters you have to carry on the job.

The Gasport Tester's poison-tolerant methane sensor provides three measurement ranges for your daily service needs:

- Open air, safety sampling
- Small, in-home leak detection
- Street/outdoor service line leak detection
