# **FRUITLAND OUTCROP MONITORING REPORT**

**LA PLATA COUNTY, COLORADO**

**OCTOBER 2004**

**LT ENVIRONMENTAL, INC.  
4400 West 46<sup>th</sup> Avenue  
Denver, Colorado 80212  
(303) 433-9788**

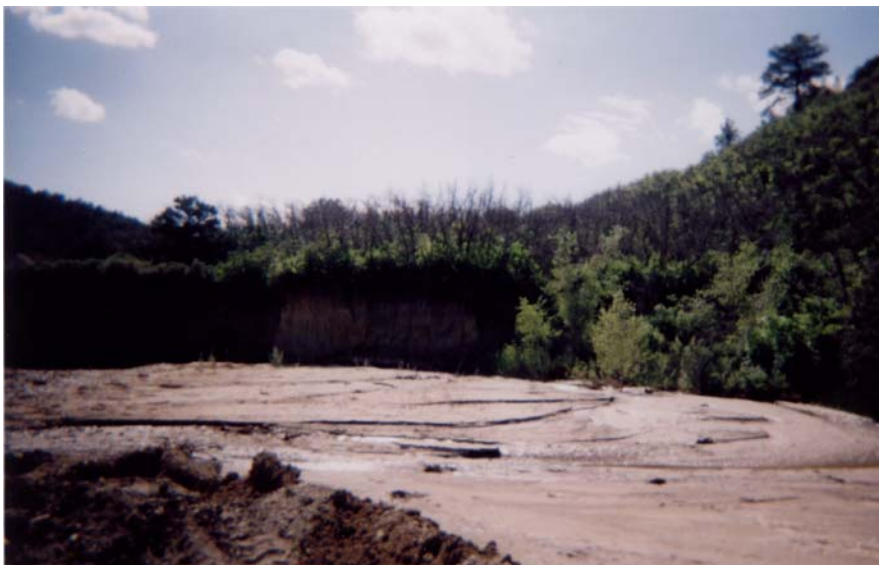
The stream bed in the Basin Creek area was not mapped due to construction activities. The construction of the dam, and removal of vegetation caused large quantities of sediment to accumulate in the stream bed, thus making the area inaccessible for seep mapping. The areas

Sediment in Basin Creek  
View east.

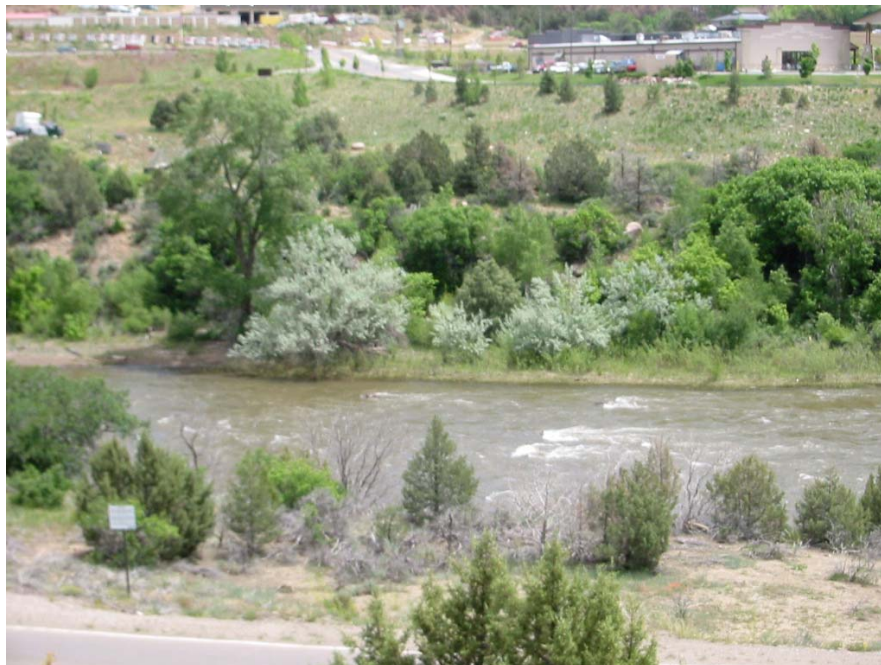
Animas River at  
Carbon Junction,  
view north.

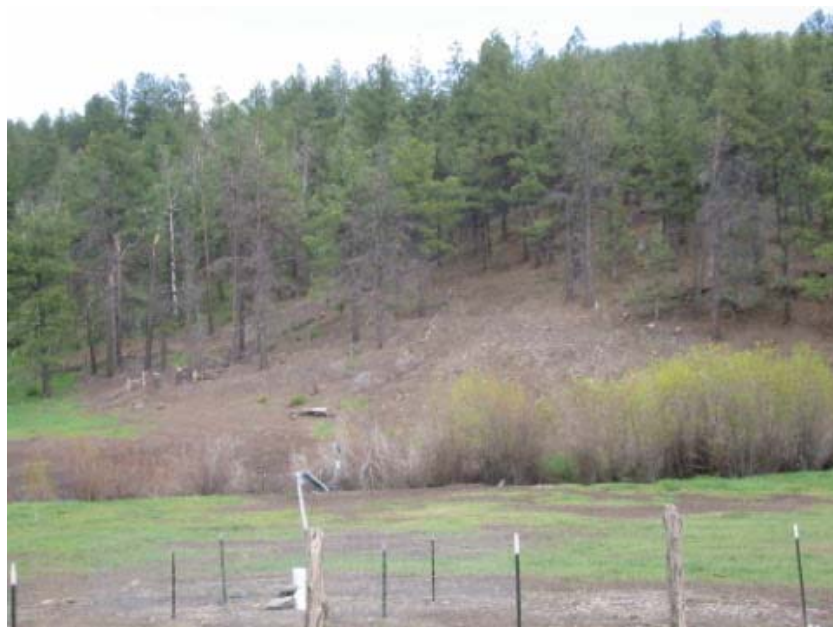
approximately 200 feet north and south of the flux chamber (TC-1, Figure 17). Approximately 0.34 miles west of the main seep area a visible seep area (approximately 100 feet by 200 feet) was observed where the creek had flooded the meadow (TC-2, Figure 16).

Location TC-1,  
view east
