**RESULTS OF A SOIL GAS SURVEY,  
WEST DIVIDE CREEK AREA  
NEAR SILT, COLORADO**

**Anthony W. Gorody, Ph. D., CPG 9798  
Universal Geoscience Consulting, Inc.**

**November 15, 2004**

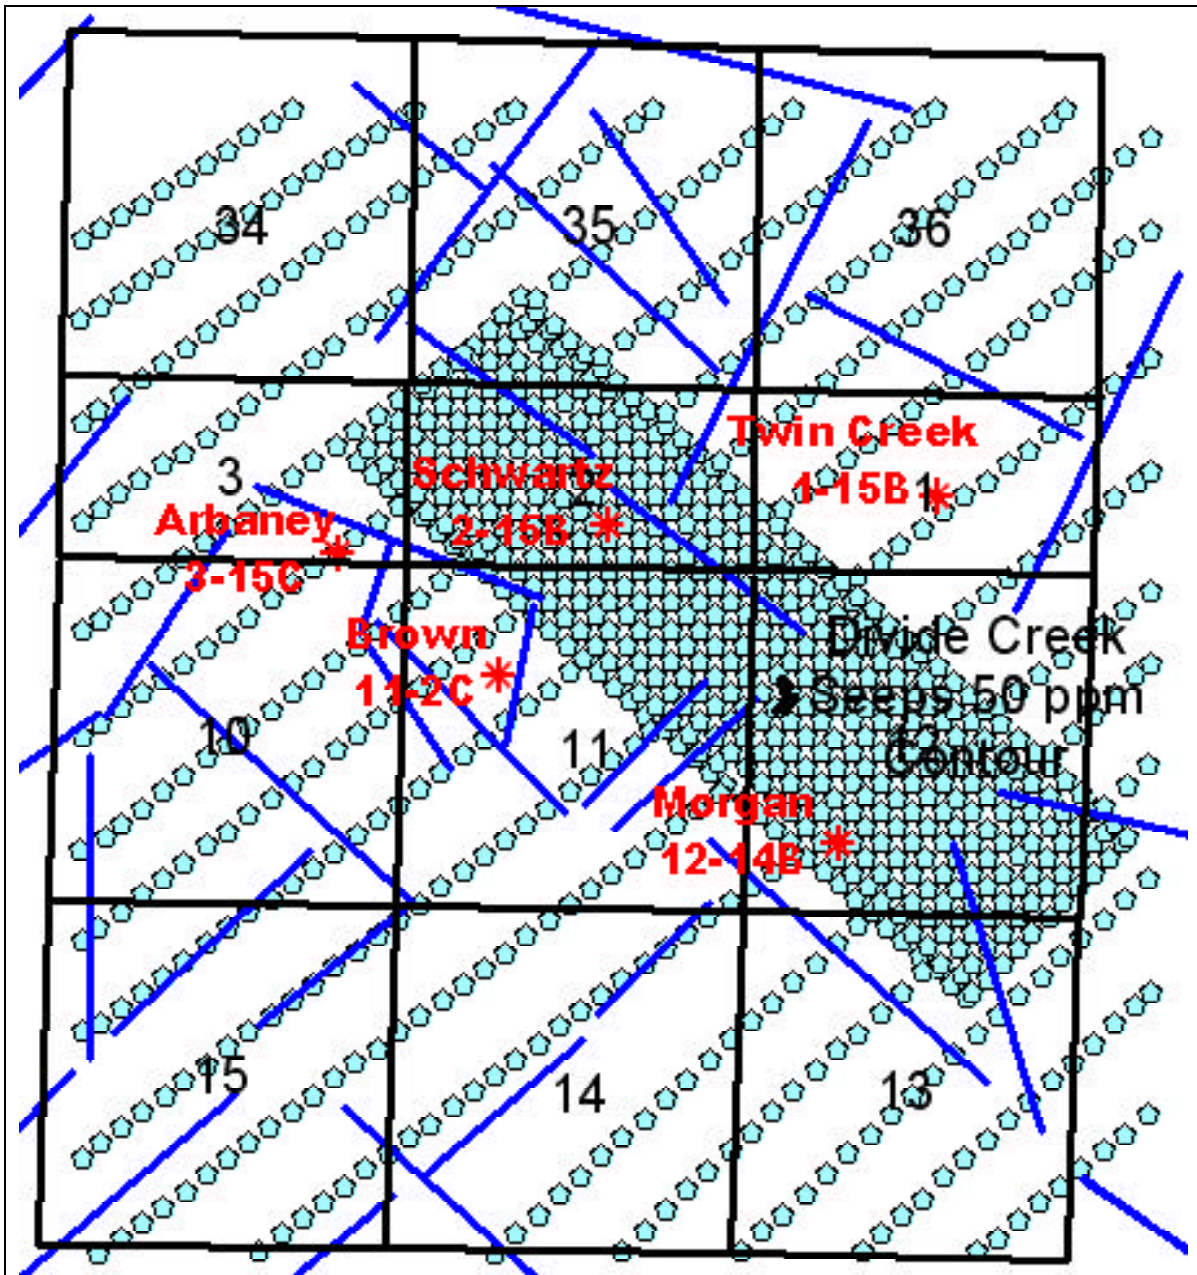
Figure 4. Grid plan programmed into the GPS unit used to guide the ground survey.

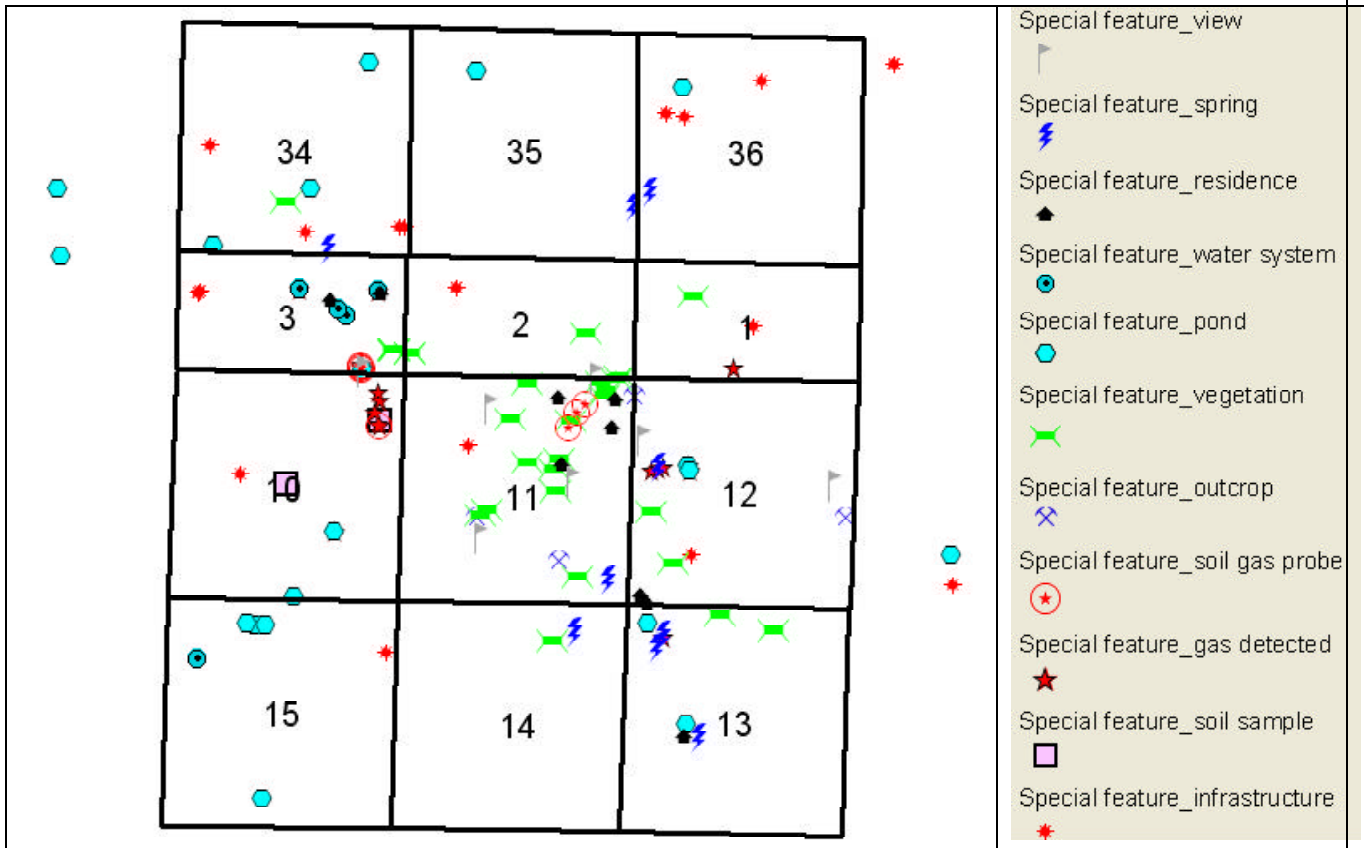
Figure 6. Graphic summary showing the location of special features addressed during the survey.

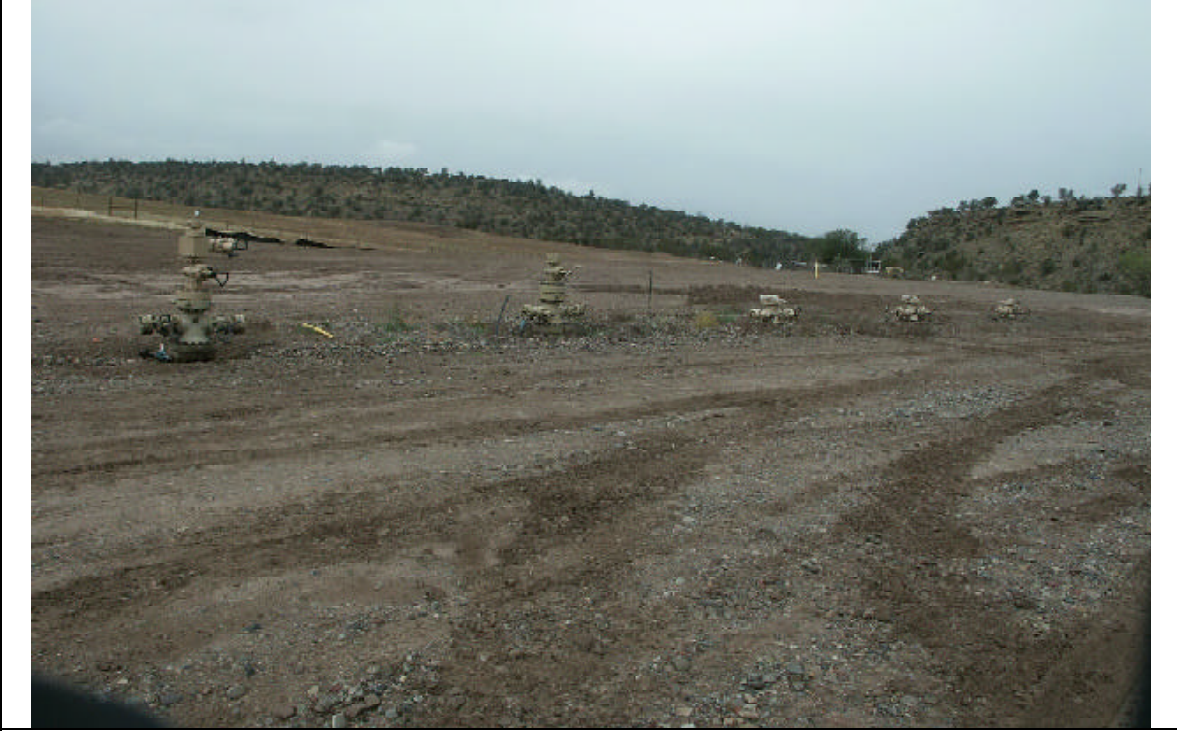
Figure 8. Five producing wells on the EnCana P3 pad. North is to the right, and the Magic 10-1 well is on the left.

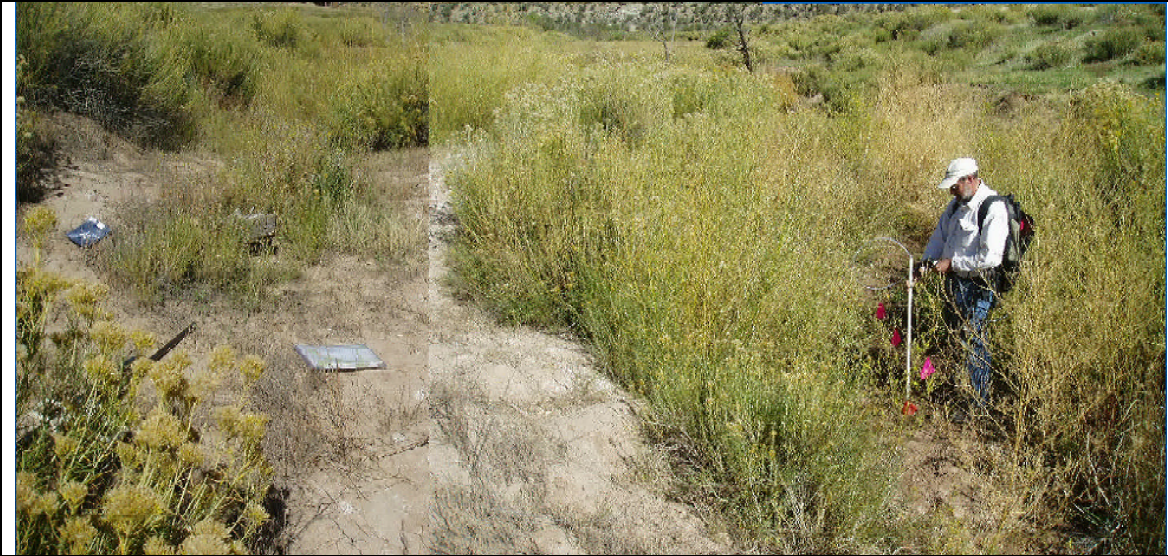
Figure 10. Installing Dietrich C5 soil probe in area of highest soil gas concentrations detected at Dietrich Seep 1. Stressed vegetation visible on left hand side of this photo composite. Salt crusts show up as white spots on bare soil.

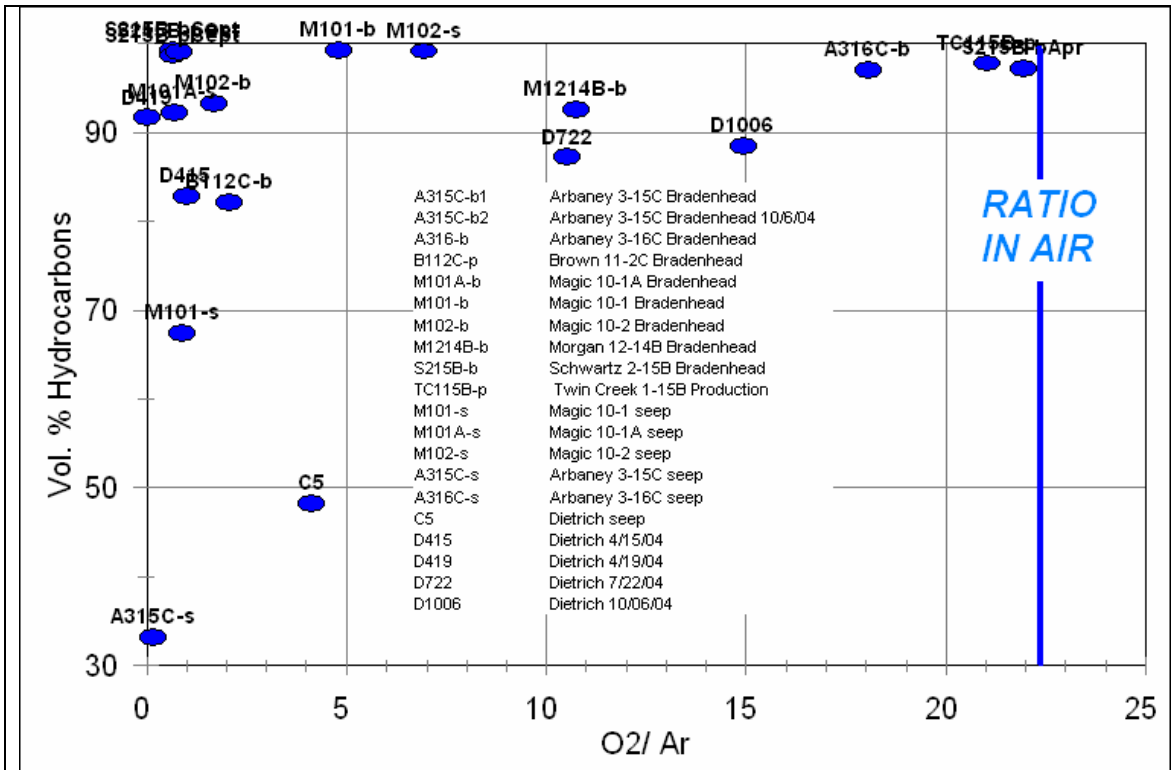
Figure 14: Data showing the good quality of soil and bradenhead gas samples collected for hydrocarbon analysis.

Figure 14 shows a plot of these two variables. Samples collected from the Schwartz 2-15B bradenhead, the Arbaney 3-16C bradenhead, and Twin Creek production wells contain highly concentrated hydrocarbon volumes with a small amount of contaminant air. Samples containing lower hydrocarbon volumes, such as those from the Magic 10-1, C5, and Arbaney 3-15C seeps, contain modified air with low oxygen contents that reflect reducing conditions in the soil. Values from the Dietrich well also reflect the reducing conditions of the water in the well. The data therefore show that the quality of the samples is excellent.

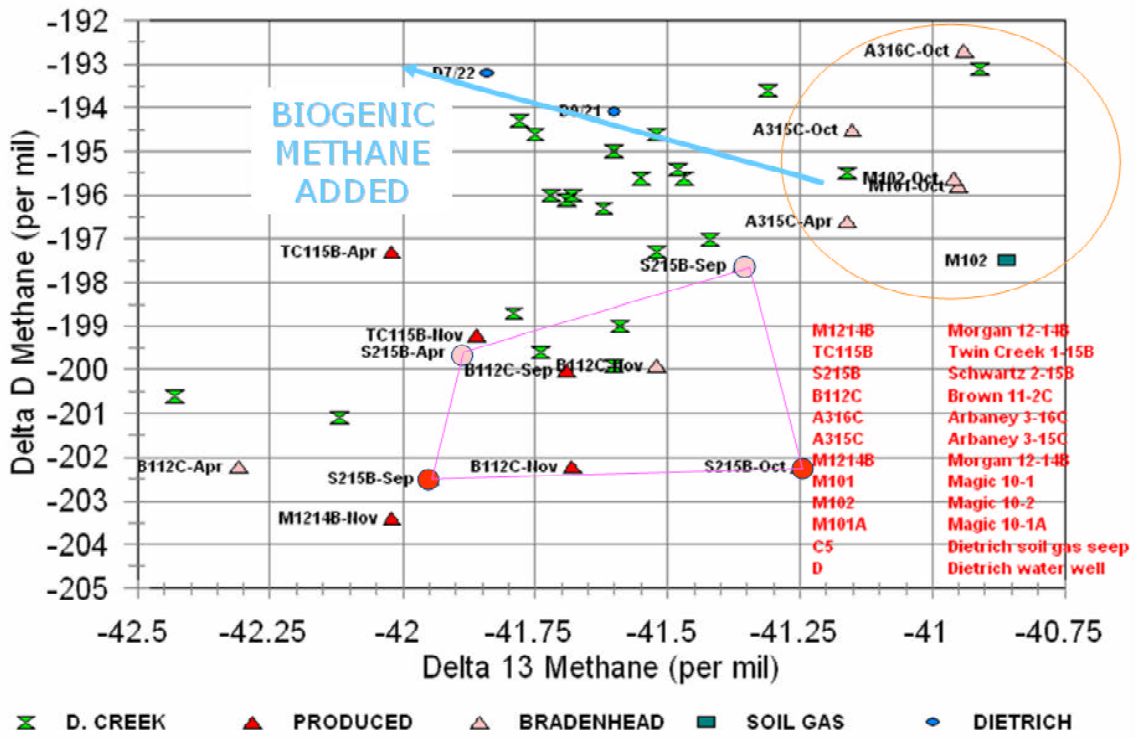
Figure 16. Enlargement of stable methane and deuterium isotope ratios outlined in red on Figure 15.

Figure 16 also shows the influence of methane oxidation among the West Divide Creek seep samples; sample data show stretched carbon isotope ratios between -42.5 and -40.75 per mil, and stretched deuterium ratios between -210 and -193 per mil. Another trend commonly observed in soil samples among Rocky Mountain basins relates to the occurrence of biogenic methane (of microbial origin). Pure biogenic methane in groundwater contains very negative carbon isotope ratios, on the order of -76 per mil, and deuterium values between -200 and -210 per mil. Addition of bacterial methane to methane of thermogenic origin drives isotopic ratios towards more negative values (trend of blue arrow shown in Figure 16). The scatter towards more positive stable carbon isotope ratios observed in Divide Creek and Dietrich water well samples indicates the influence of mixed biogenic methane.

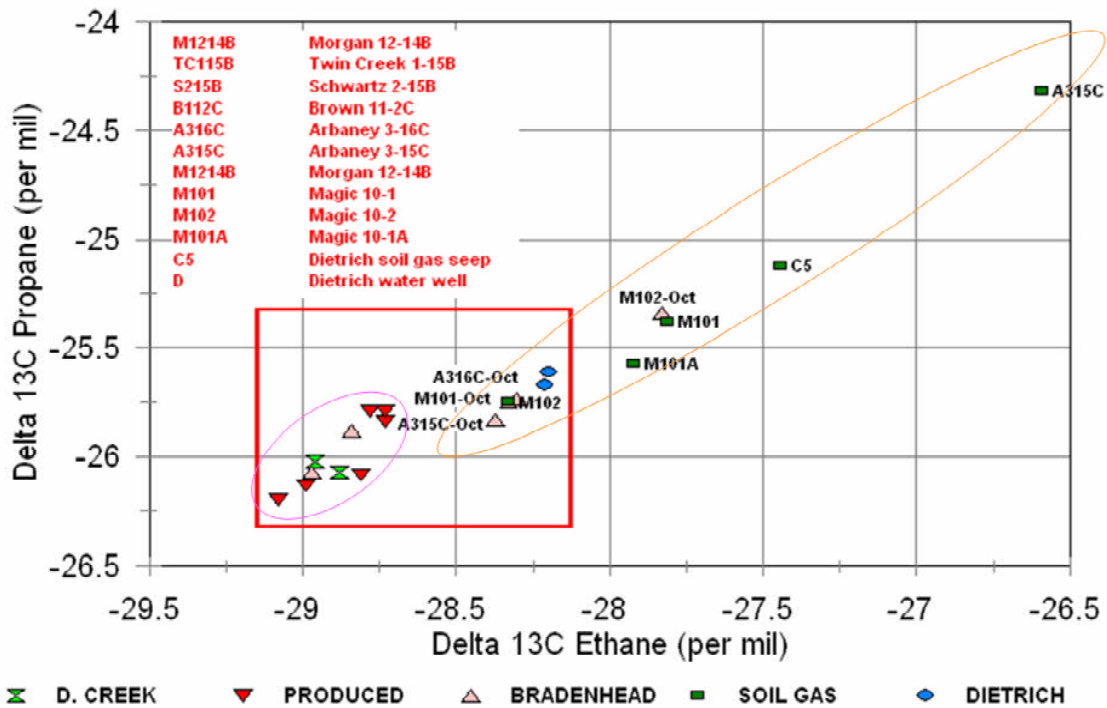
Figure 17. Stable isotope results for carbon in ethane and propane. P3 pad soil gas samples, P3 pad bradenhead samples, and Dietrich water well samples fall in a different region from Divide Creek Seep, and other wellhead gas and bradenhead samples.

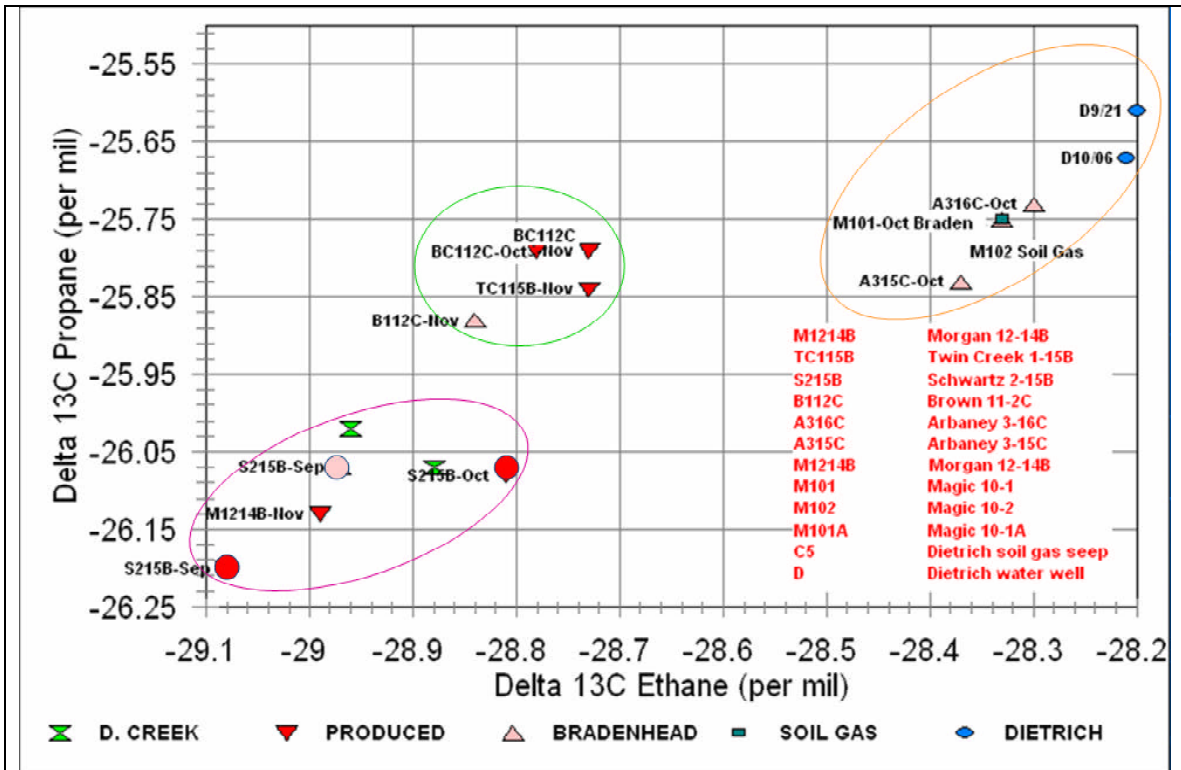
Figure 18. Enlargement of stable ethane and propane carbon isotopes outlined in red on Figure 17.

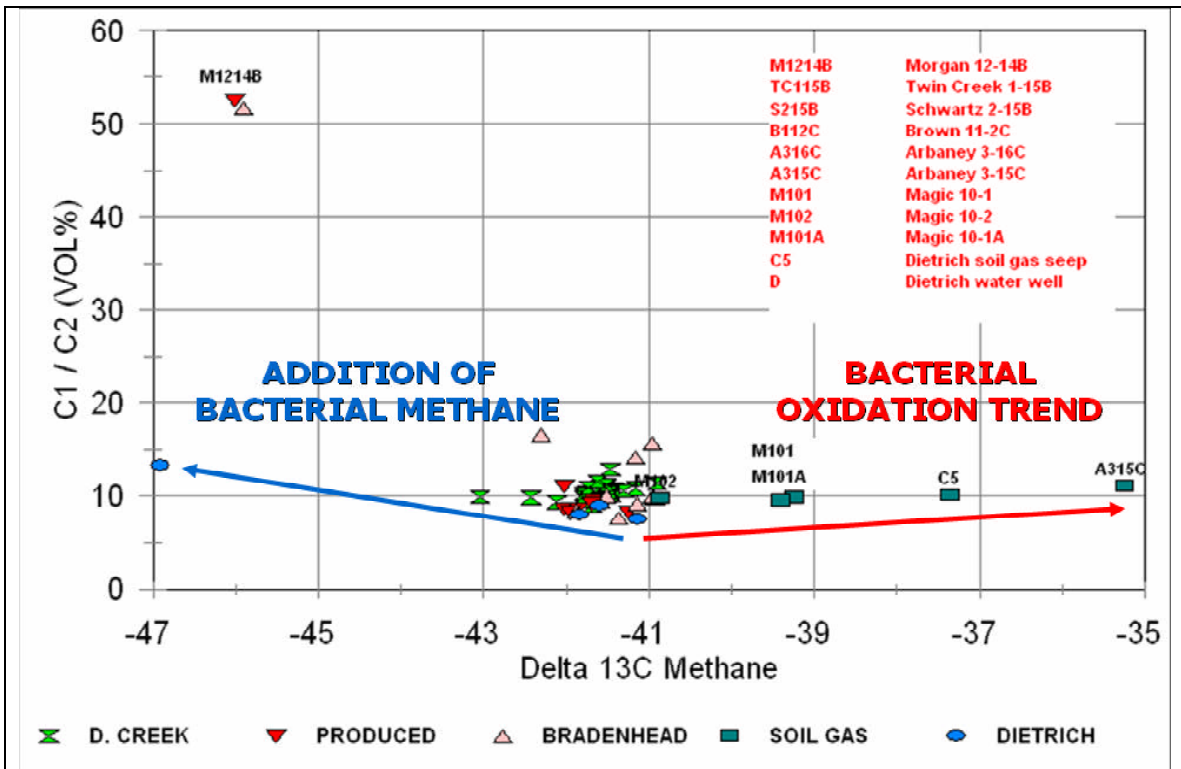
Figure 19. Methane to ethane ratio data showing the influence of bacterially-mediated alteration.

Figure 19 shows that the gas samples found in all soil gas samples and the Dietrich water well is of thermogenic origin. If methane ( $C_1$ ) and ethane ( $C_2$ ) were of purely biogenic origin, then the  $C_1/C_2$  ratio would be greater than 1000. Values less than 50 are characteristic of thermogenic sources. On that basis, thermogenic  $C_1/C_2$  ratios for the Morgan 12-14B wellhead and bradenhead samples are distinct from all others in the area.

The influence of bacterial alteration is illustrated in Figure 19. Bacterially-mediated oxidation reactions drive isotope ratios to more positive values as the  $C_1/C_2$  ratio increases. The ratio increases because bacteria consume ethane at a greater rate than they consume methane. Thus the thermogenic gas found in soil probes at the P3 pad and on the Dietrich property has been significantly altered. The least altered sample originates in soil near the Magic 10-2 well.

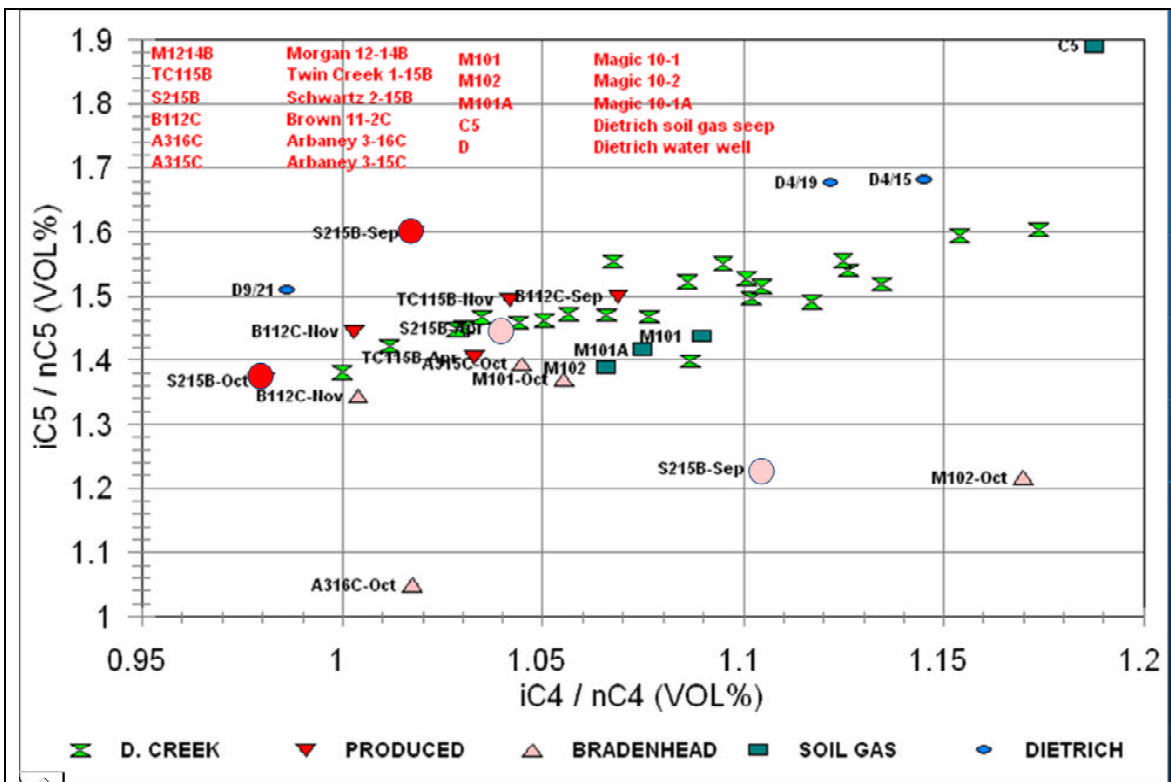
Figure 23. Enlargement of butane and pentane isomer ratios outlined in red on Figure 21.

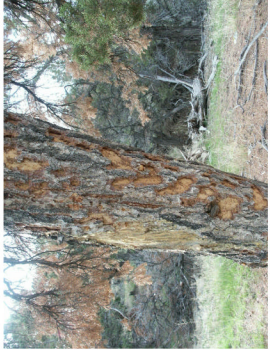
100504\_PICT2486.JPG

Griffin Veg 2	10/5/04	100504_PICT2484.JPG	Recent dead pines near well house and small excavation, beetle & woodpecker damage.
Griffin Veg 2	10/5/04	100504_PICT2486.JPG	Recent dead pines near well house and small excavation; close up of beetle damage.
Thompson Veg 4	10/6/04	100604_PA060001.JPG	Dying pine trees along road/driveway going up to Thompson residence, closest to home.
Thompson Veg 4	10/6/04	100604_PA060002.JPG	Dying pine trees along road/driveway going up to Thompson residence, view of house.
Thompson Veg 4	10/6/04	100604_PA060003.JPG	Dying pine trees along road/driveway going up to Thompson residence, farther down road.
Thompson Veg 1	10/6/04	100604_PICT2487.JPG	(2) lg mature pine tree kills, beetle & woodpecker holes & missing bark on lower trunk.
Thompson Veg 1	10/6/04	100604_PICT2488.JPG	Pine tree kills along Thompson's road.
BLM View 1	10/6/04	100604_PICT2489.JPG	View over W Divide Creek, looking W
